# Turf Preparation for the '64 Open

By **Walter E. Gallagher**, Green Chairman,  
and  
**Frank J. Murphy, Jr.**, General Chairman, 64th USGA Open

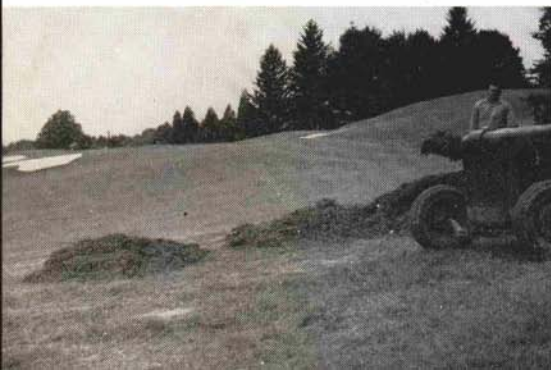
Photo 1—Load after load of thatch, loose bermudagrass runners, and other vegetative matter was removed from each fairway.

First, a thatching machine cutting a swath of four feet and to a depth of 3/4 to one inch was used on the fairways. The thatcher was pulled by a tractor and operated off the tractor's power take-off. Following immediately behind this blade a tractor pulled a sweeper which was driven by its own motor and which picked up the thatch, loose runners, dead grass, and crabgrass seedheads in its hopper.

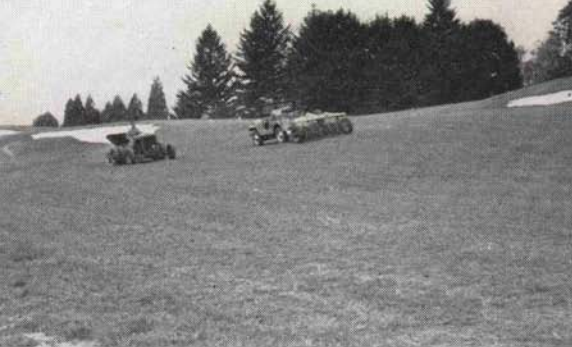
Photo 2—Fertilizer spreader begins its work while the aeration unit is finishing up on this fairway.

Second, the fairway was aerated 10 times to a depth of 1/2 to 3/4 inch. Aeration units were fitted with 3/4 inch spoons. At the completion of this operation a mixture of bentgrass containing 20% Seaside, 30% Astoria, and 50% Highland was sown at the rate of 70 pounds per acre. The fairways then were dragged with a heavy chain link fence drag after which they were mowed twice, cutting in opposite directions. (See Photos 2-3).

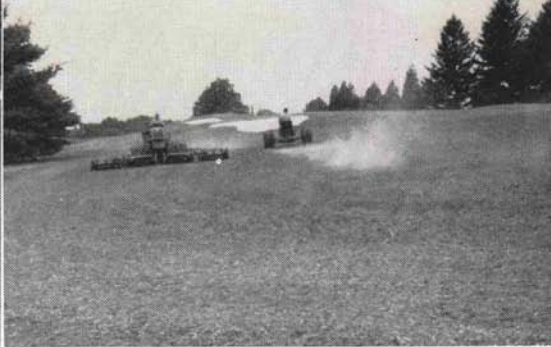
Photo 3—Dragging and mowing operations.

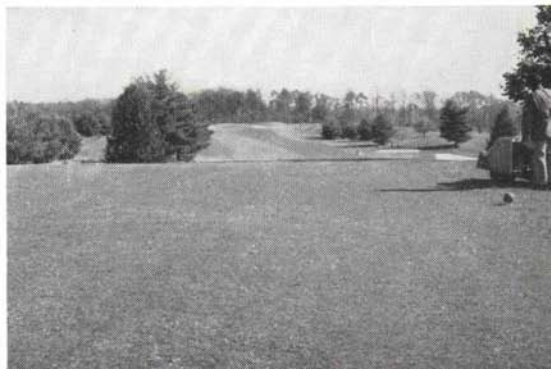
Photo 4—A view of the No. 3 hole from the championship tee six weeks after renovation.

During the last two weeks in September an application of organic sludge at the rate of 700 pounds per acre was made. Because soil tests indicated a need for it, an application of 3,000 pounds of ground limestone per acre was made during October. On four of the fairways, where the tests showed the soil to be lacking in magnesium, the dolomitic type of limestone was applied. On the remaining fairways the regular ground limestone (60 mesh) was applied. (See Photo 4).
