Solving Drainage Problems at El Macero

by **D. W. HENDERSON*** and **DON T. BRADLEY**, Department of Water Science
and Engineering, University of California, Davis, and
JACK JAGUR, Superintendent, El Macero Country Club, El Macero, California

After several greens at El Macero Country Club deteriorated badly in 1966 and large areas of grass died, several possible causes were investigated. Also, some different procedures for drainage were tried and evaluated. Possibly our experiences may be of value to others with problem greens.

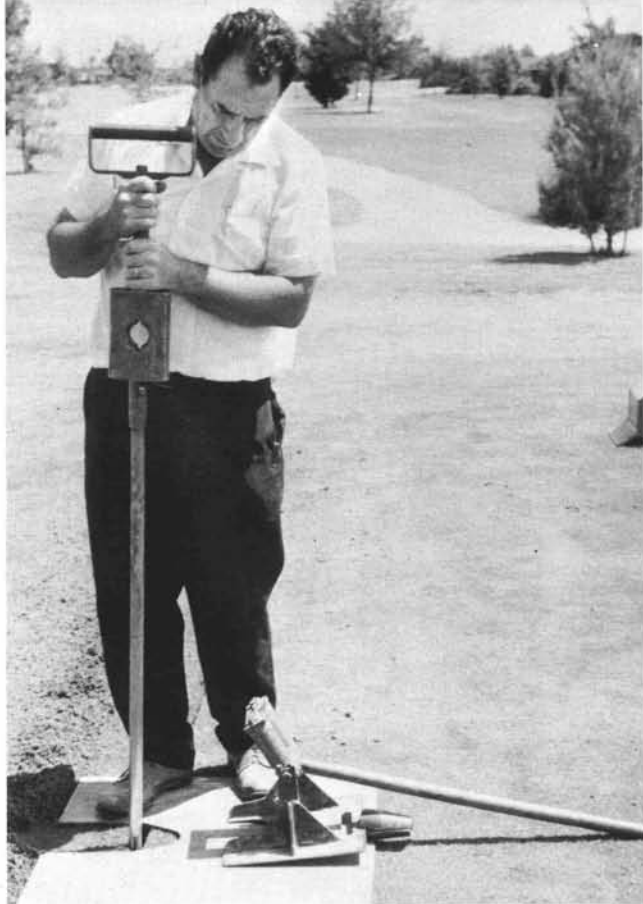
Dr. Henderson at work with a hammer-driven soil sampling tube on No. 2 green.
