## *Restoring A Limestone Wall*

by PETER BILD, Superintendent, Glen Flora Country Club, Waukegan, Illinois

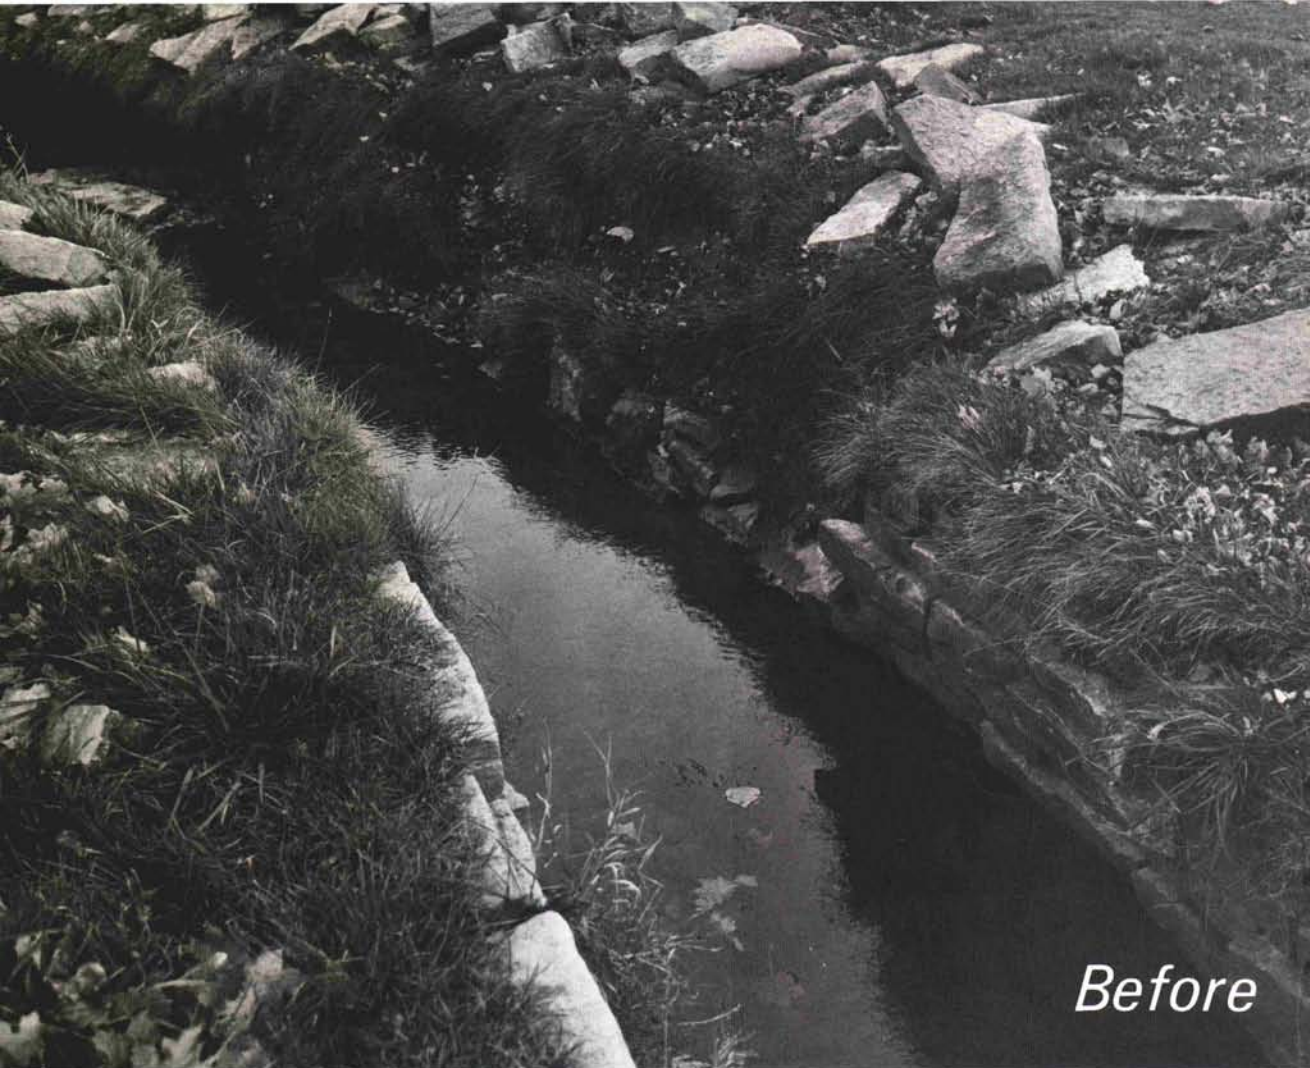
*Before*

The original wall stood for 13 years, but gradually succumbed to the ravages of winter frost and spring flooding. Eventually, sections

of the wall crumbled and erosion was once again a problem on the stream banks. It was decided most practical to rebuild the wall completely. Because it seemed more economical to use our own labor rather than hire an outside contractor, work on the wall was necessarily delayed until the latter part of August, 1970, when some labor time was available.
