Water Quality and Drainage

by JAMES A. McPHILOMY, Golf Course Superintendent,
Valley Country Club, Denver, Colorado

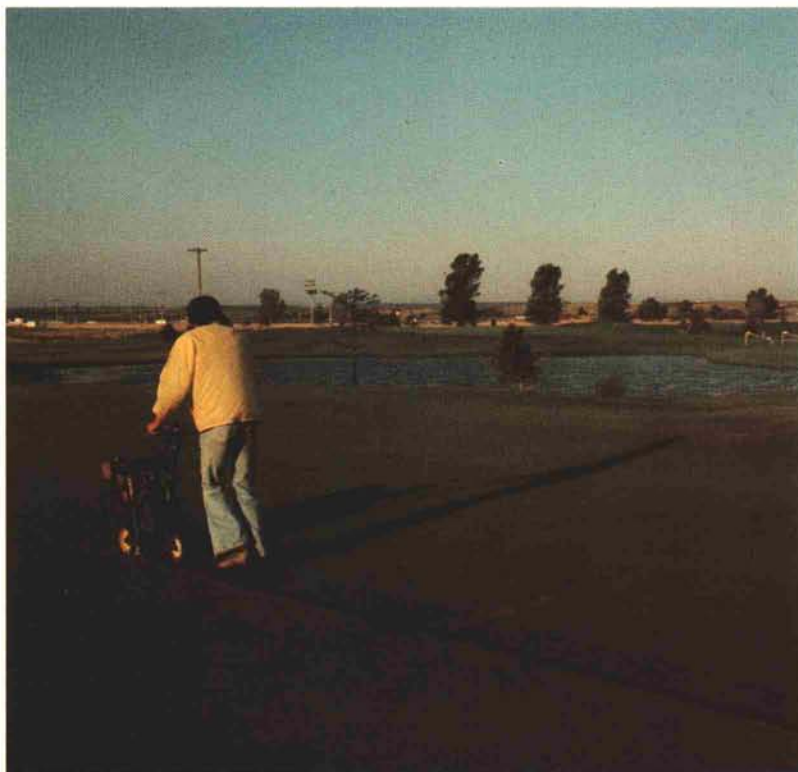
(Left) Sod is stripped where main drain is to be installed.

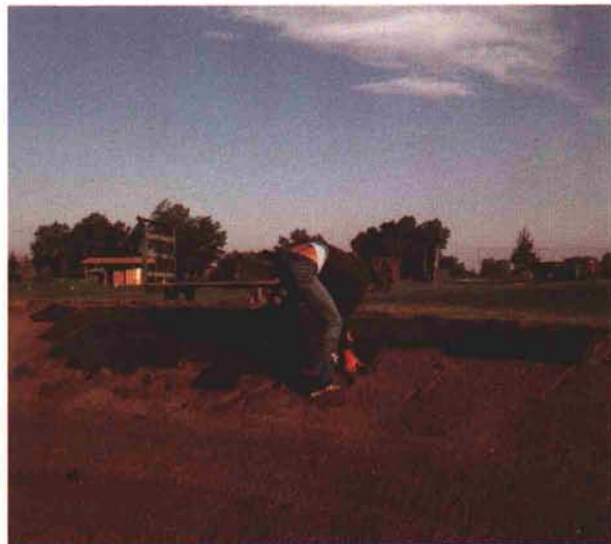
(Below) Preserving the stripped sod by placing it on sand in greenside bunker.

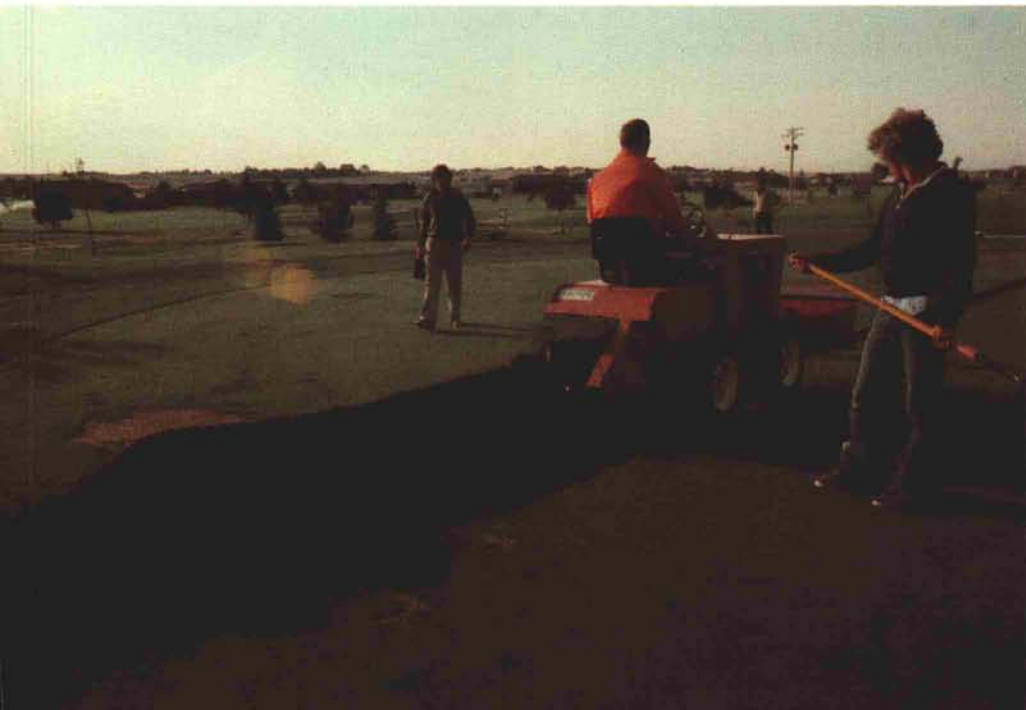
(Left) Trenching for the main line.

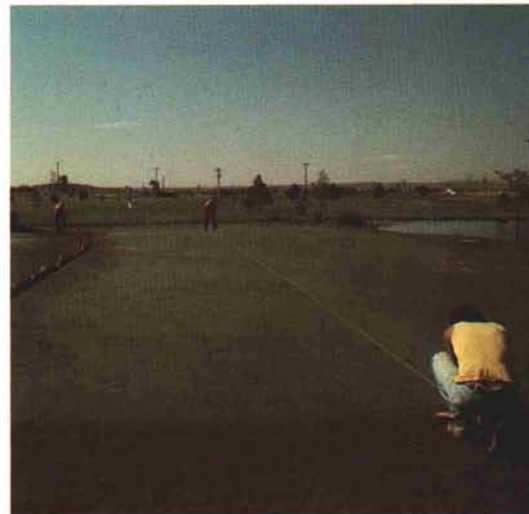
(Above) Measuring and marking for lateral drains.

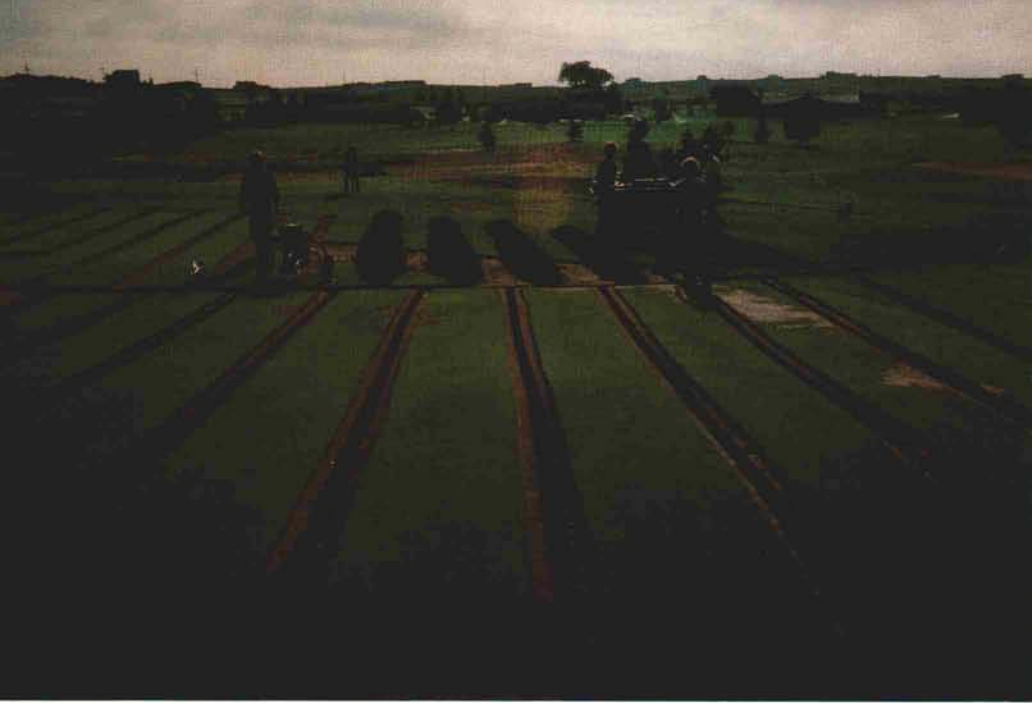
(Top, left) Lateral drain trenching and clean-up.

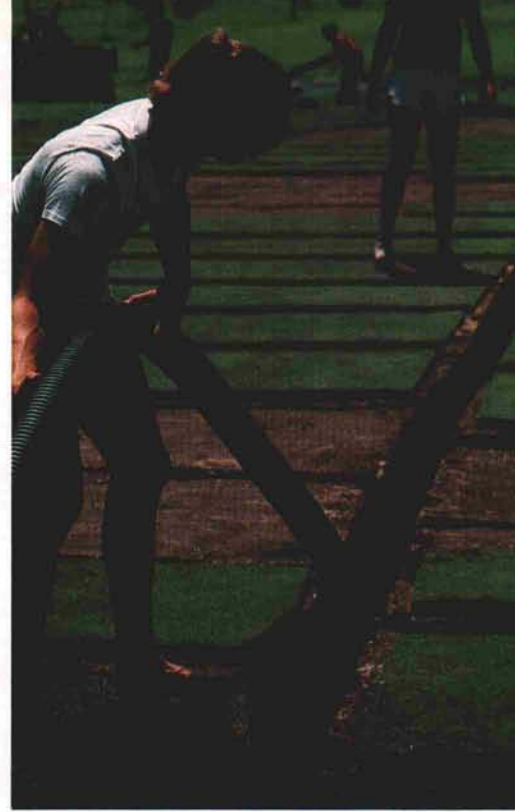
(Top, right) Installing main drain — perforated continuous plastic pipe (tubing).

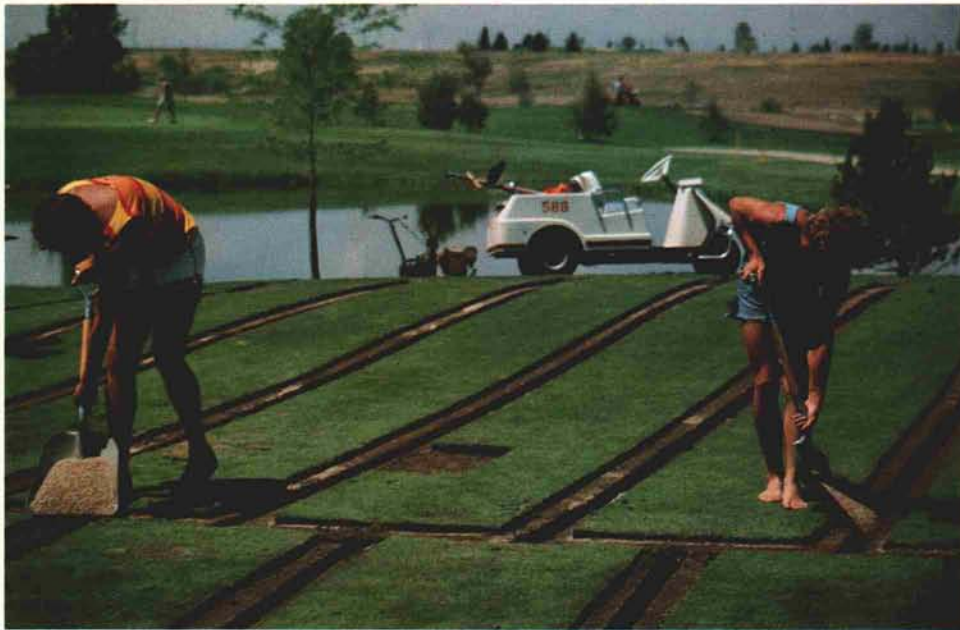
(Above) Placing gravel in trenches.

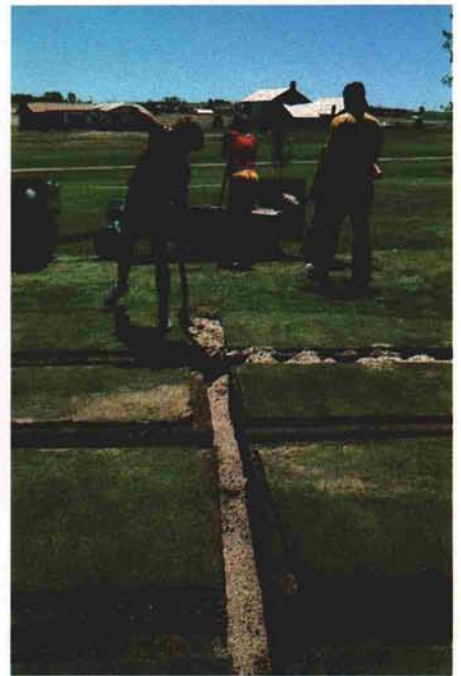
(Right) Placing sand over gravel.

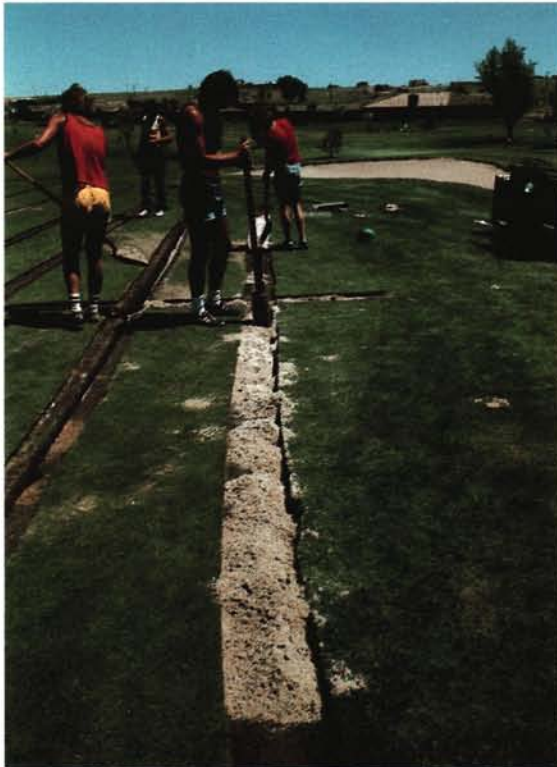
(Far left) Hand tamping of the sand.

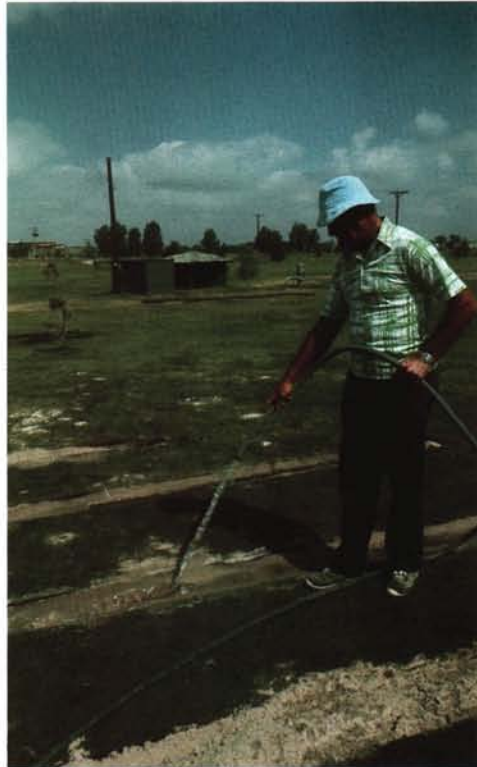
(Left) Water-packing to further compact the sand.

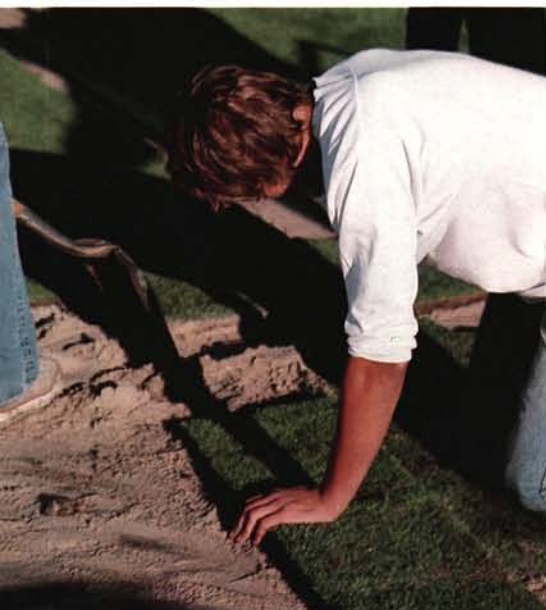
(Below, left) Replacing sod.

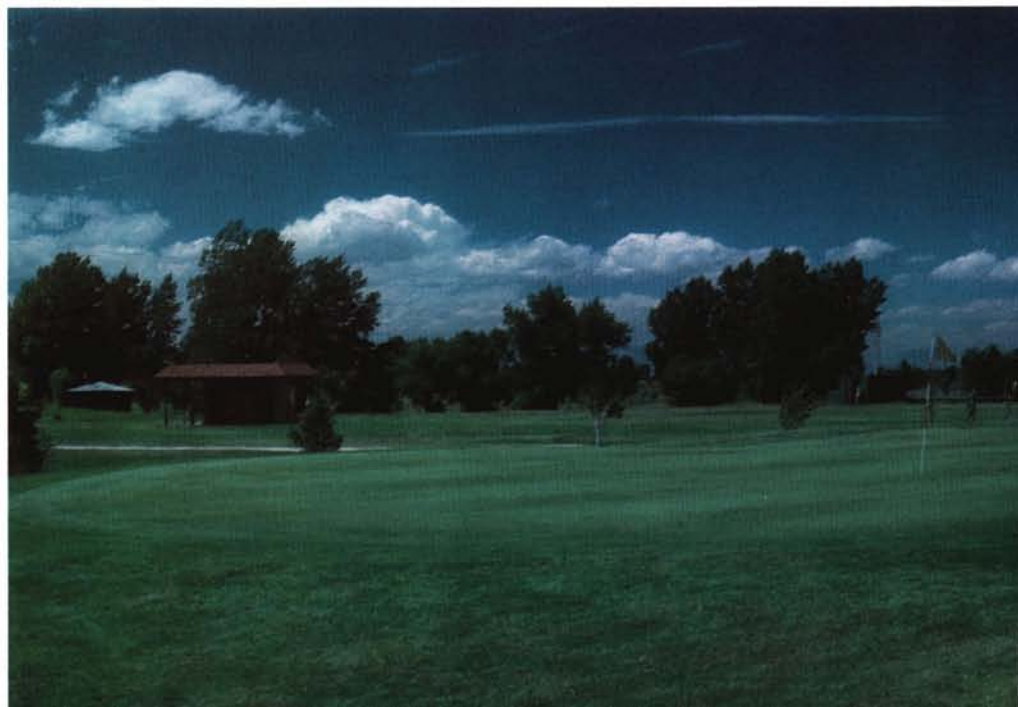
(Below) View of green 14 days after completion.
