Biting the Bullet: Greens Complex Reconstruction at the Country Club of Virginia

by ALAN D. HESS, C.G.C.S.

Director of Golf, Country Club of Virginia, Richmond, Virginia

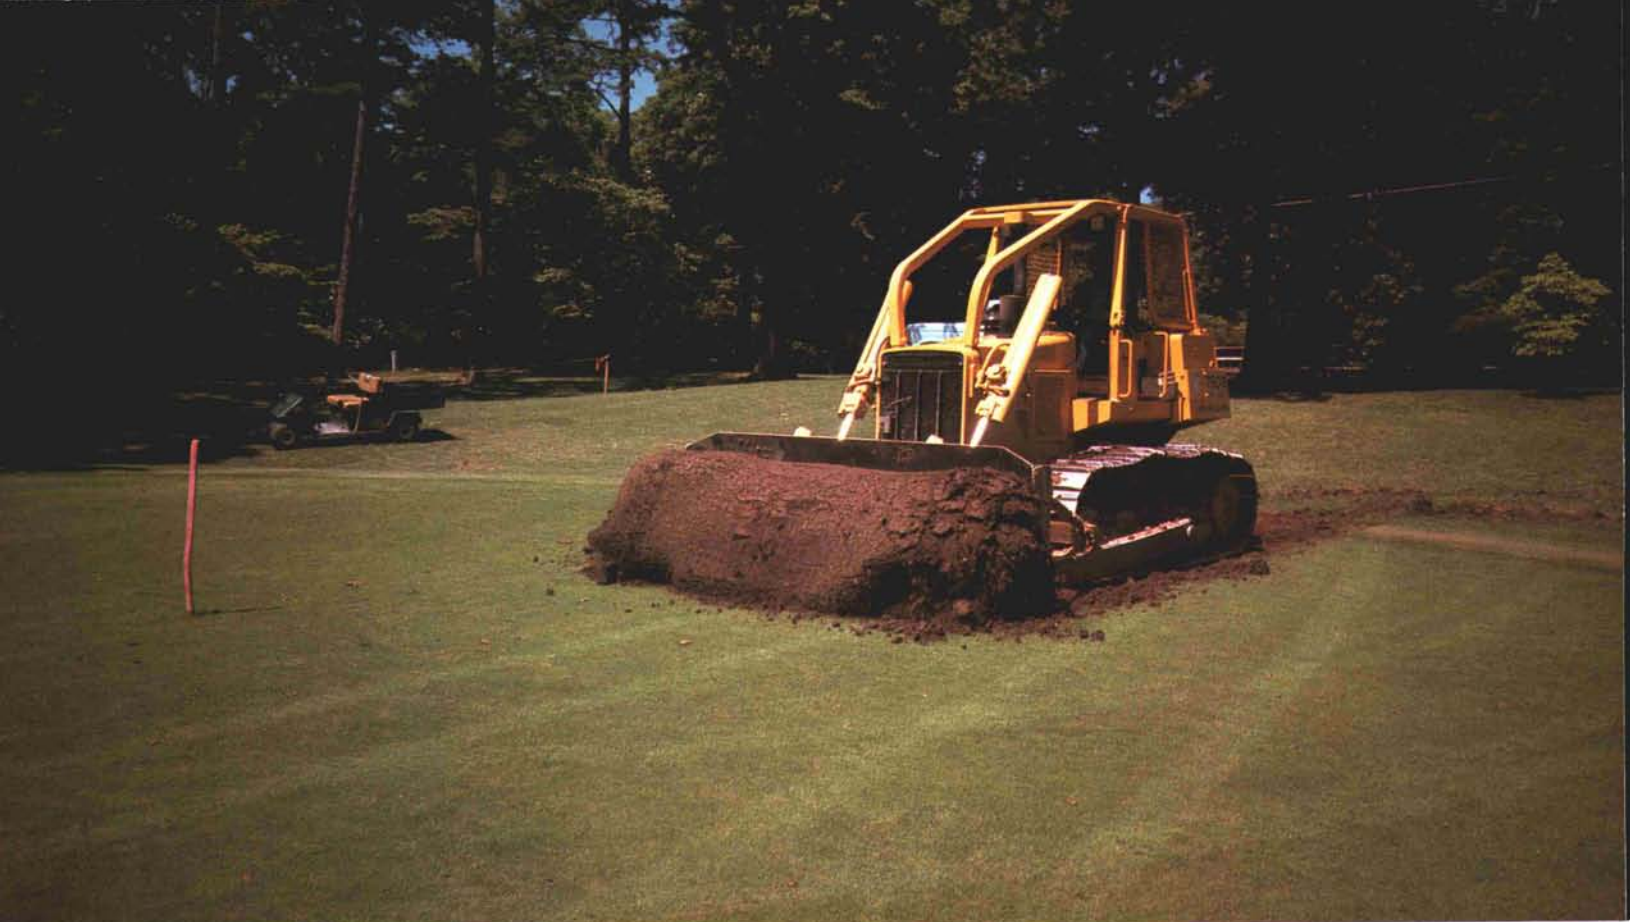
(Above) Taking the blade to a problem green.

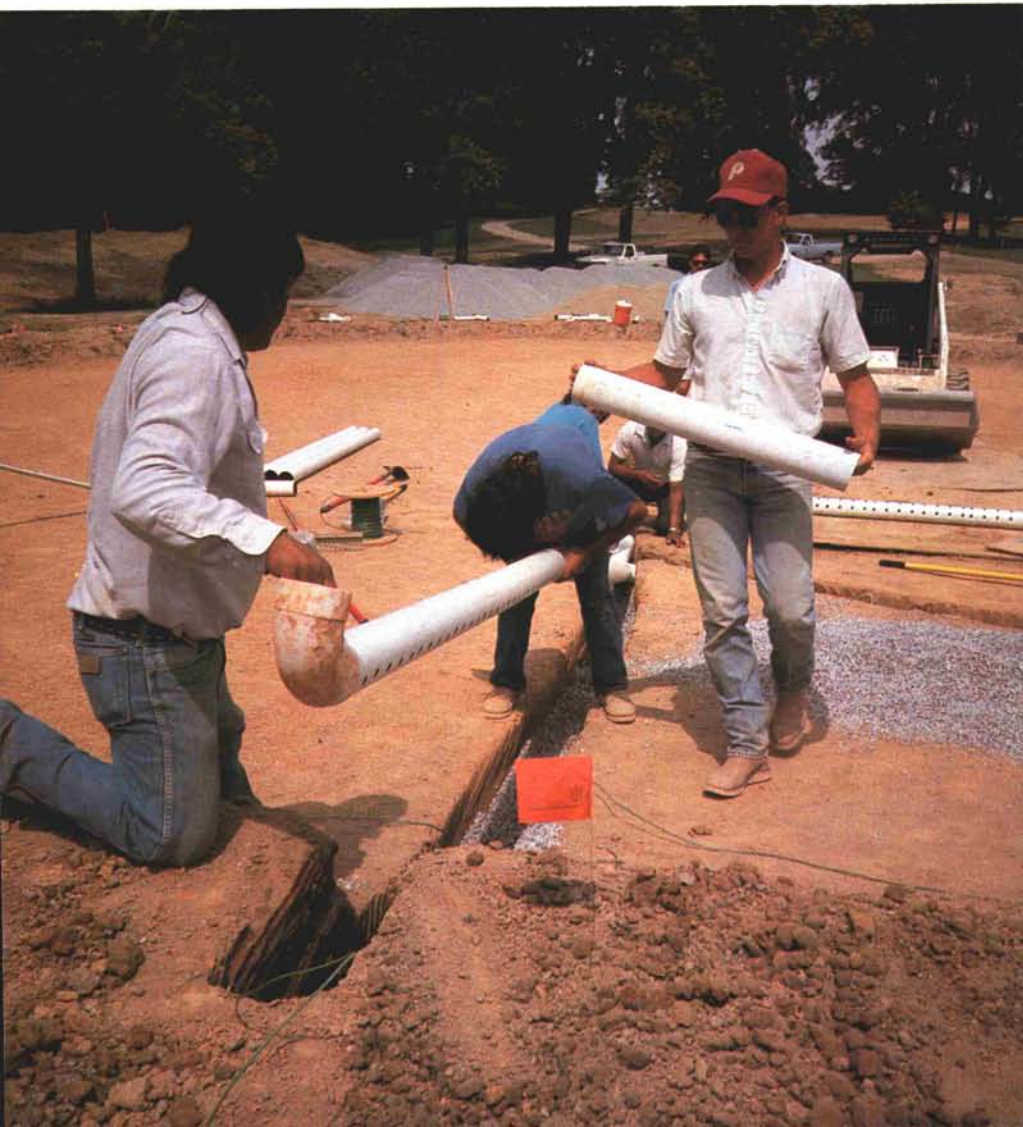
(Left) At the rear portion of the seventh green, an elbow section was installed as the basis for a flush-out drain for the main line. The orifice for this flush-out will be protected by a valve box.

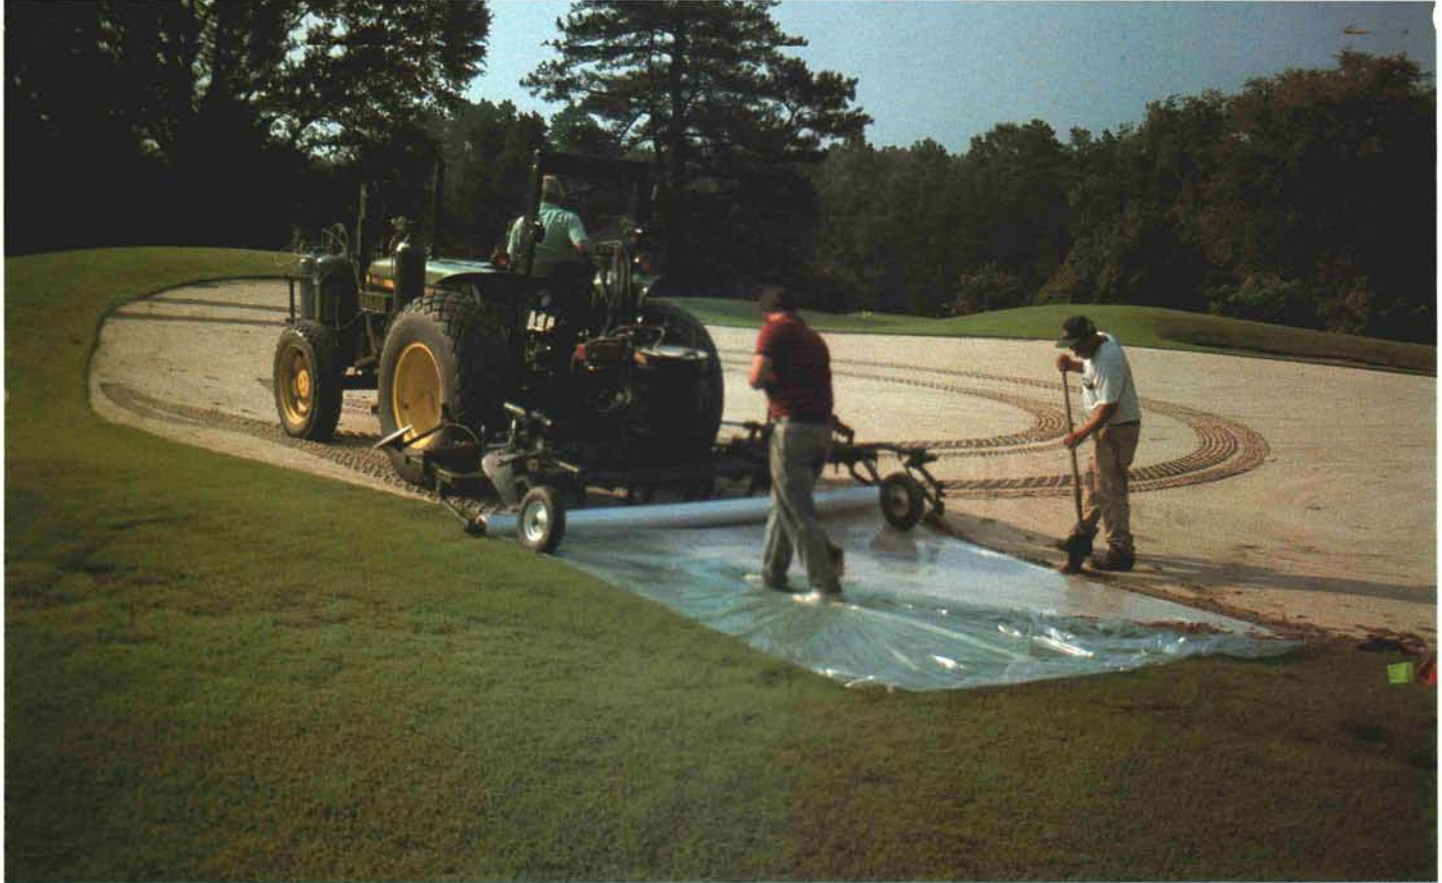
Methyl bromide fumigation was a key step prior to the seed bed preparation. We were convinced this was necessary due to the amount of bermudagrass established during construction on the green cavity wall.
