Forty Years With A Drainage Problem

by JAMES W. DUDLEY, Athens Country Club, Athens, Georgia

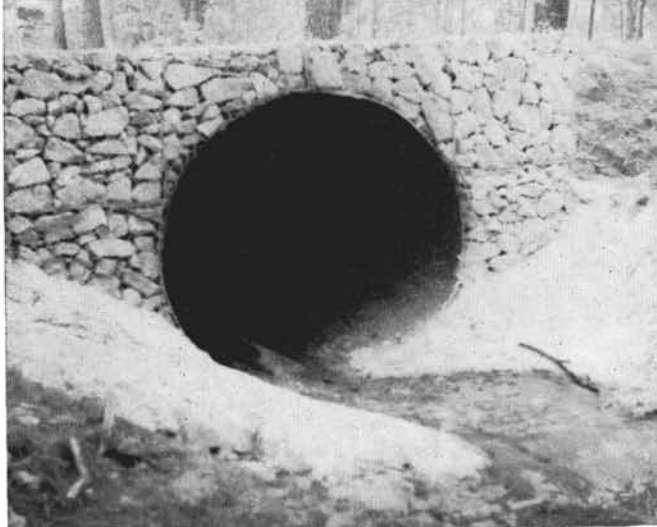
The beginning of the 640 feet of the 84" metal drain pipe laid at 2.5% grade with two reinforced concrete catch basins.

4. For the trouble area around the dam and lake, Beacham designed 640 feet of 84-inch metal drain pipe, fully asphalt coated, with a paved invert. This was set on a 2.5 percent grade and included two drop catch basins of concrete that serve to dissipate the force of water, and also as cleanouts in case debris collects during floods.

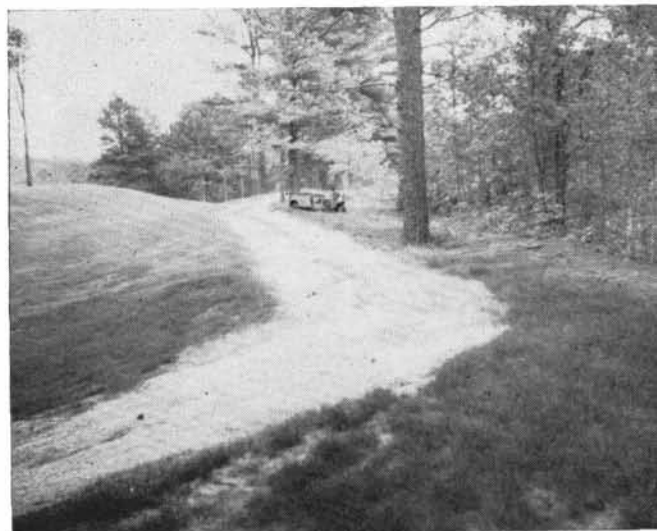
The drain ditch is covered and the metal pipe in underground. Major floods can go to the extreme left if pipe is too small.

2. Since the drainage ditch had always been a maintenance problem, we decided to pave the bottom of the ditch approximately five feet wide with 24-inch slopes to carry normal water flow. This will allow all of our equipment to maintain slopes without hand work.

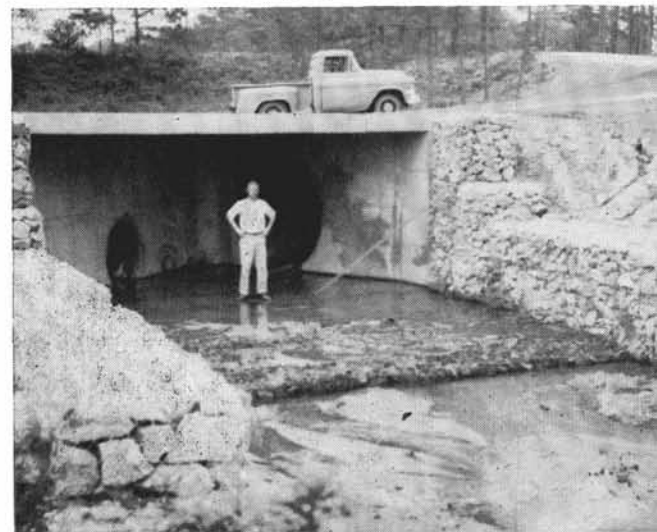
The outlet with gabion shows the end of a 40-year drainage problem.

5. The terminal catch basin also includes a 30-foot section of gabion wall and floor as added protection to the banks of the creek. This material, a series of galvanized metal baskets filled with stones, was chosen since it is flexible enough to change positions due to settling without the danger of cracking.
