Recontouring a Golf Green Without Total Reconstruction

Two case studies on how to change severely sloped greens. BY DEAN GRAVES AND TIM KENNELLY

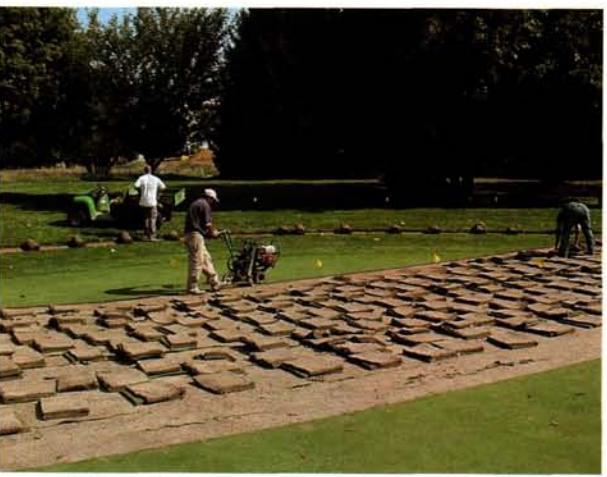
To begin the recontouring project, Baltimore Country Club (Maryland) stripped and folded the sod prior to removing it from the 12th green.

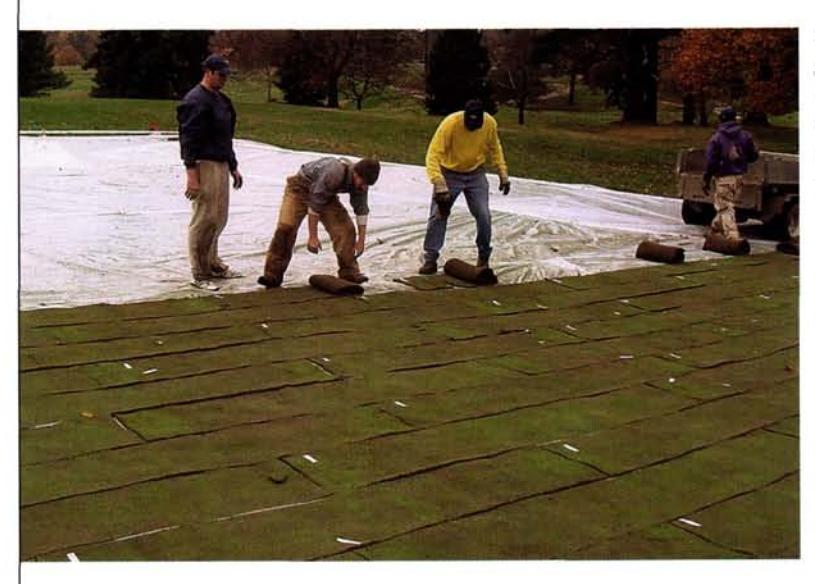
Sod from the green was cut at a depth of 1/2 inch and placed on plastic adjacent to the green. The Chevy Chase Club maintenance staff carefully numbered each sod strip so that it could be relaid in the same location when the recontouring was completed.

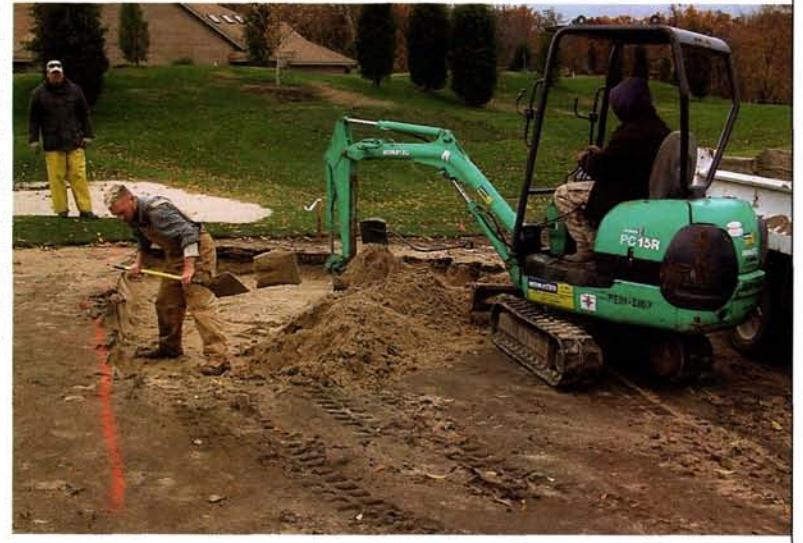
A mini-excavator was used in the Chevy Chase project to remove the appropriate amount of mix without disturbing the gravel layer and construction mix.

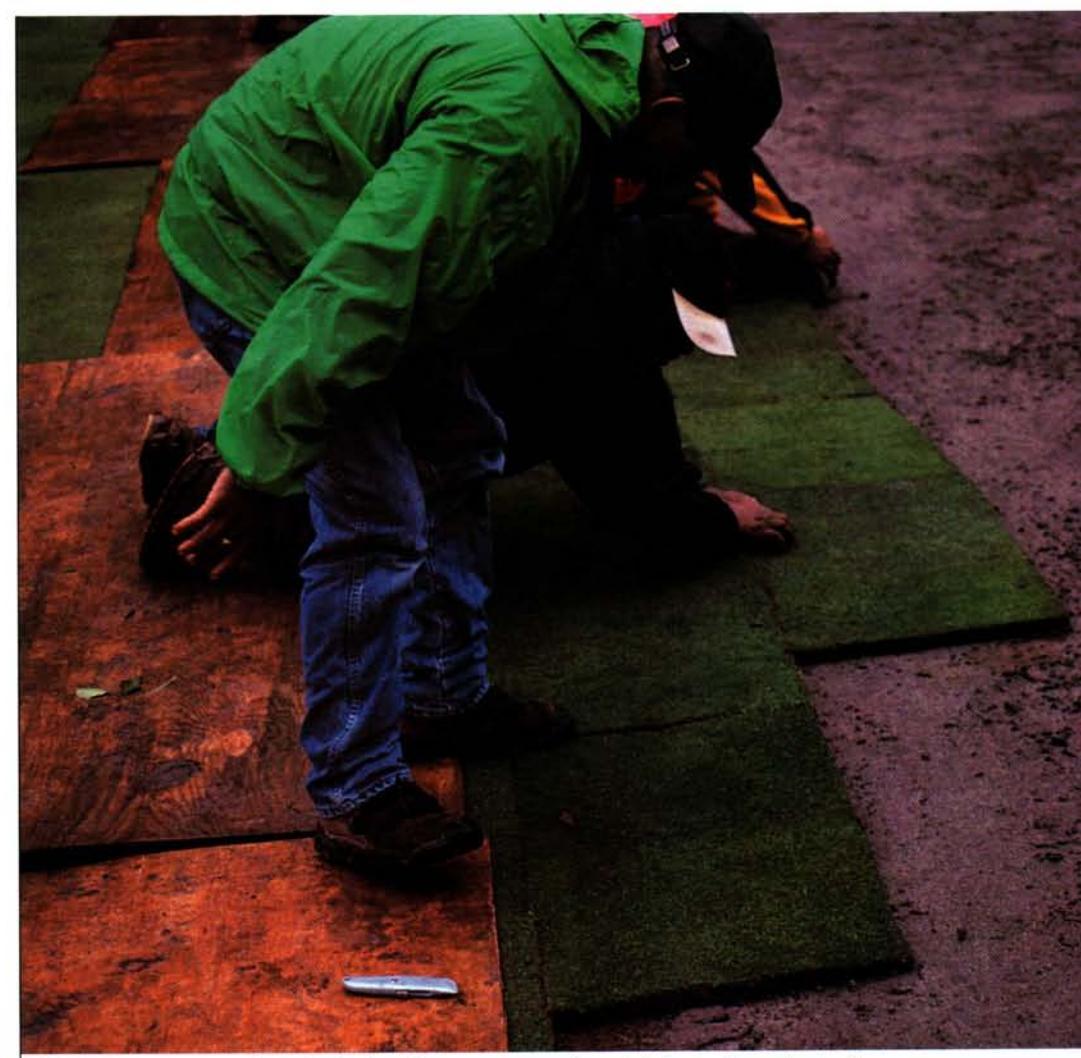
With the project complete, the final grade was compacted to minimize settling prior to the reinstallation of the sod.
