WET GREENS: LET'S TRY THIS FIRST

by LES CARPENTER Superintendent, Roxiticus Golf Club, Mendham, N.J.,

and DAVID A. OATIS Director, Northeastern Region, USGA Green Section

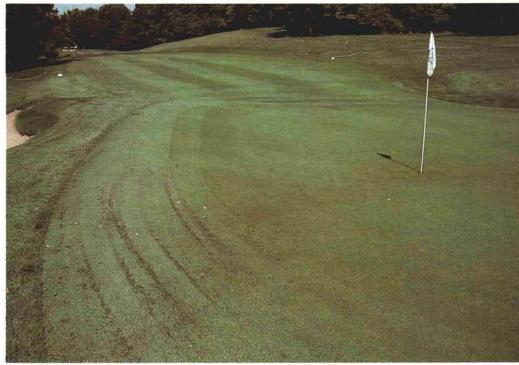
Before drainage was installed, the green remained wet and soft for several days after a rainfall.

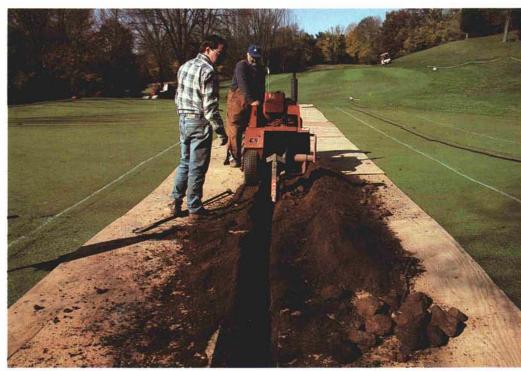
Plywood sheets were laid down along the trench line to protect the turf and make cleanup easy.

The next step was to bring in a sod cutter. The sod was cut and moved out of the way by hand. Half-inch plywood was then laid out on each side of the proposed trench. On one side, the $4' \times 8'$ sheets of plywood were laid end to end, but on the side where the trencher would throw the soil, the plywood was laid side by side. This was done to provide additional area for the soil and to allow a small maintenance vehicle to be driven on the plywood alongside the trench to help with soil removal.

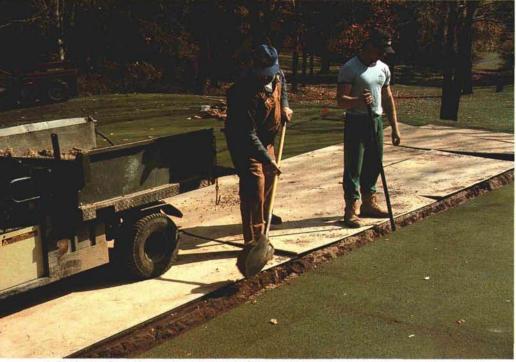
A thin layer of gravel was put in the trench, followed by 3-inch perforated drainage tile and more gravel. Topmix was added and tamped in layers to minimize possible settling problems.

Grades were checked frequently, and after the trench was thoroughly cleaned and leveled, a thin layer of ³/₄" gravel was spread evenly and tamped to prevent future settling. Three-inch perforated flexible drainpipe was then laid in the trench, and several layers of gravel were added and tamped until the top of the gravel was approximately 12" below the surface of the green. A manifold type of arrangement was used to connect the drain lines from the green to existing drains located nearby. NOTE: The high ends of the drain lines were extended well out into the first cut of rough and were brought to the surface and enclosed in a valve box. This provides a clean-out mechanism in the event of future problems, and a method to check how well the drain lines are functioning.

After some experimentation, we decided to make our own root zone mix with which to backfill the drainage trenches. The mix consisted of an 80% sand and 20% soil combination. We hoped that it would have adequate water- and nutrient-holding capacity so that the turf over the trenches would not require extra moisture or fertilizer. The mix was then added to the trench. Again, we worked in layers, with each 3" increment being gently tamped by hand. We were very concerned about future settling problems and worked diligently to prevent this by tamping carefully and thoroughly, something that Mr. Rathjens had stressed as being a key to the success of his project at Raritan Valley. We followed this advice closely, and we have not seen any significant amount of settling in the 18 months since the system was installed.

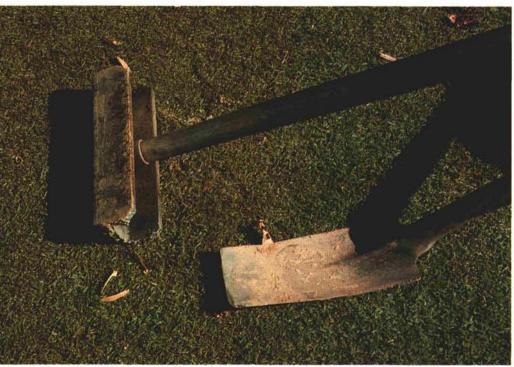
Essential tools included a narrow shovel and a tamping device made especially for the project.

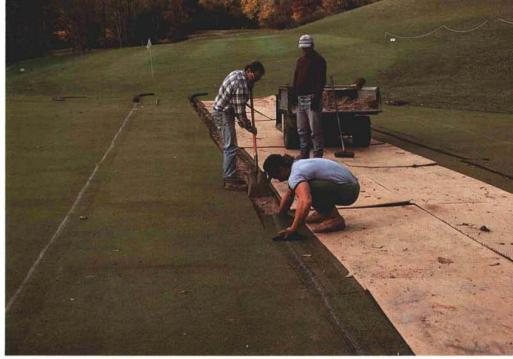
Great care was taken to replace the sod as it had been removed.

The final step was to reinstall the sod, taking care to replace it just as it was removed. After a final tamping, the green was covered with a geotextile fabric for the winter.

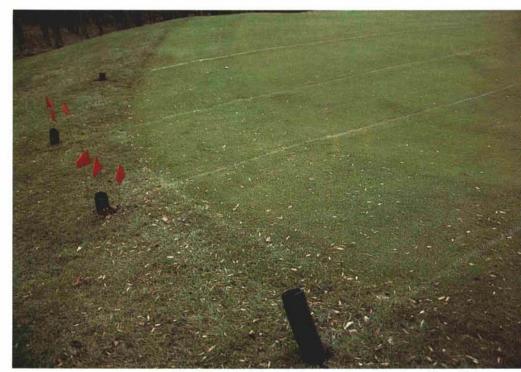
The high ends of the drain lines were brought to the surface, off the green, and eventually were attached to valve boxes for easy access.

• Extend the drain lines beyond the edges of the green by several feet in both directions. Extending the high end of the drain outside of the green and enclosing it in a valve box provides a valuable flush point. Extending the low end beyond the edge of the green is important so that connections are not made in the putting green. If additional drain lines are deemed necessary in the future, they can be installed and connected with less putting surface disturbance.

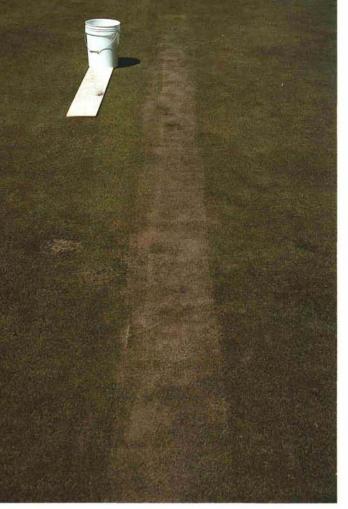
(Above left) The following spring, trench lines were topdressed several times to account for some slight settling.

The following spring the cover was removed and the trenches were topdressed as needed. Fortunately, settling was not a big problem, and we attribute that to the amount of tamping performed during the backfilling operation. The summer of 1993 was quite dry, so the system was not thoroughly tested. Nonetheless, the initial results were good enough to convince us to perform the same procedure on another green in the fall of 1993. We are hopeful that this drainage installation project will increase our water management capabilities to such an extent that complete reconstruction will not be necessary on either green. Despite an extremely wet spring in 1994, both greens have performed well to date.

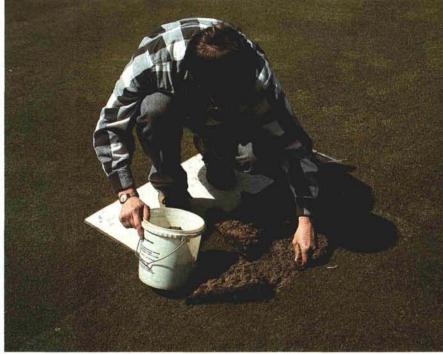
(Above right) The sod was cut back and topdressing was added where settling was more severe.

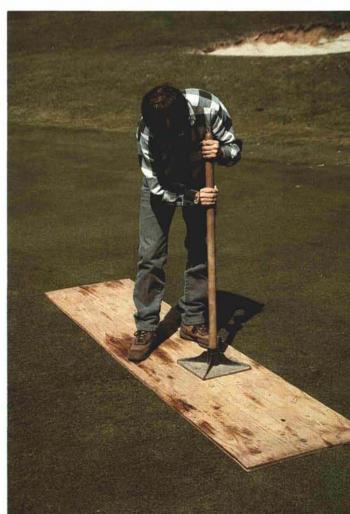
(Right) A final tamping helped smooth the sod over the trenches.
