KEEPING AN EYE OUT

Managing water quality on golf courses.

by RON DODSON

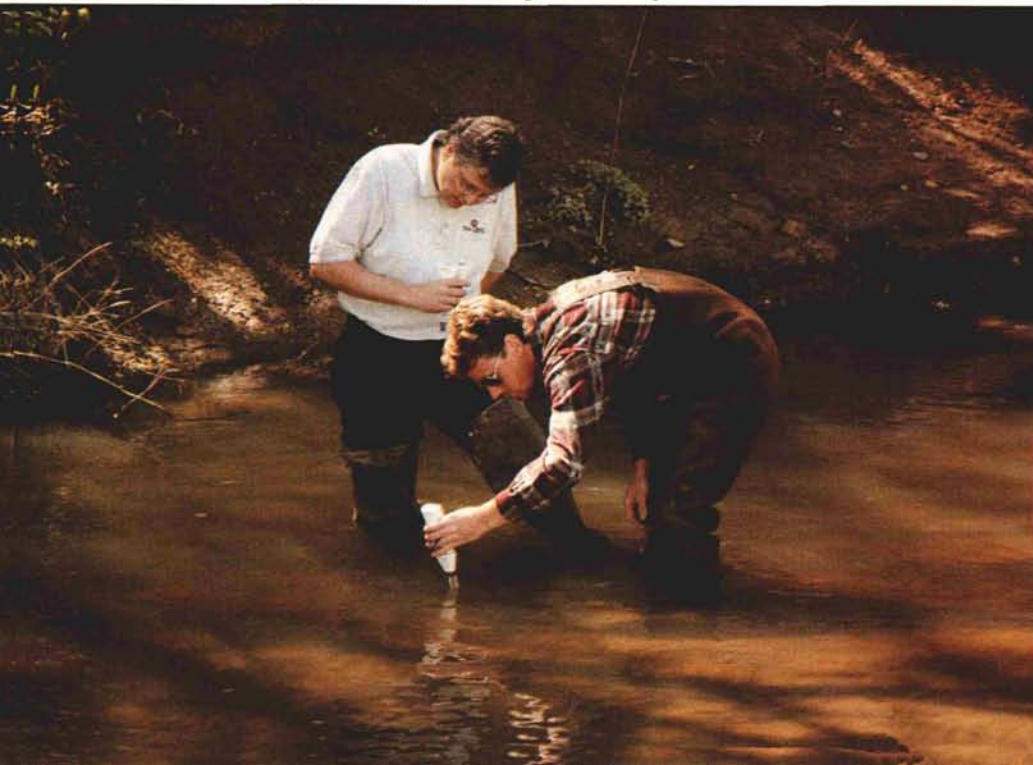
Dr. Bud Smart (left) of Audubon Conservation Services trains the Carmel Country Club staff in taking water samples.

Superintendent Hank Kerfoot has worked diligently to establish an effective water-quality testing program. He and his staff monitor water quality by regularly scheduled, comprehensive testing. Dr. Bud Smart (Audubon Conservation Services) developed a long-term plan for testing water quality at Carmel Country Club in Charlotte, North Carolina, after a site visit with Hank and his staff. The plan consists of sampling and analyzing surface water, groundwater, and sediment. Testing for pesticides also will be included based on the type of pesticide and time of year it is applied.

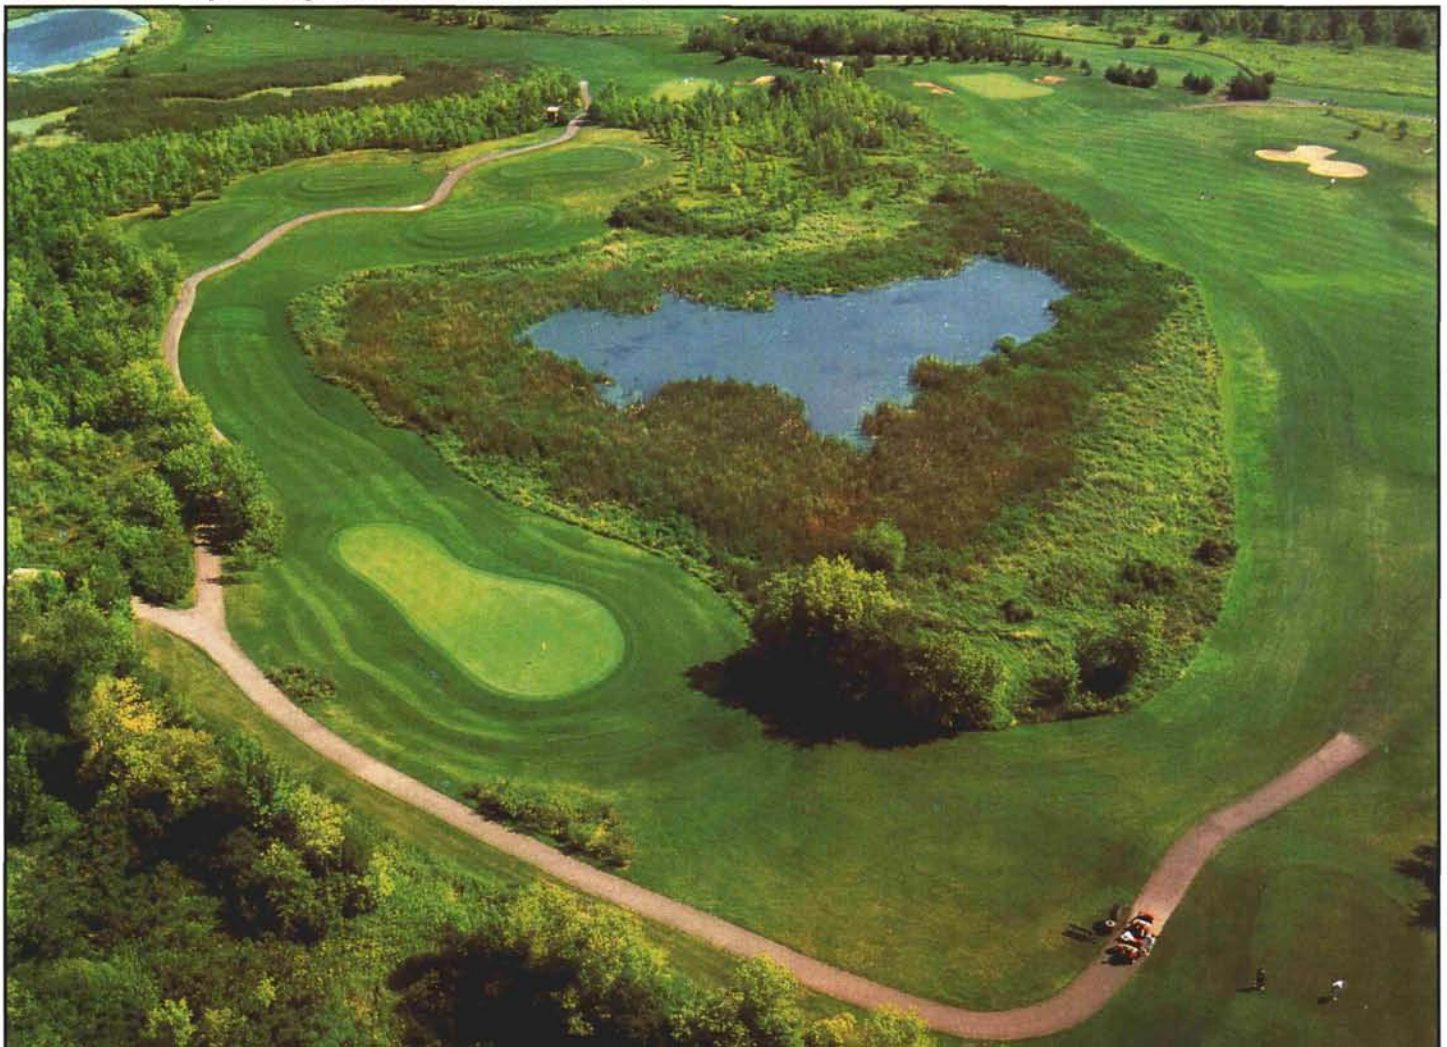
This aerial view of a restored wetland at Baker National Golf Course demonstrates the vegetative corridors that interconnect the wetland areas, providing valuable wildlife travel routes.

This golf course has done an excellent job of restoring wetlands on the course and creating vegetative buffers around these specialized areas. Many of the wetlands on the property had previously been drained for agricultural purposes. These wetlands were restored, and Keith Greeninger, course superintendent, has worked hard to maintain extensive vegetative buffers that were allowed to grow around the wetlands to reduce any potential impacts from course maintenance practices.
