# Washing Your Cares Away

Gaining an equipment wash rack upgrade as part of the turf management center master plan.

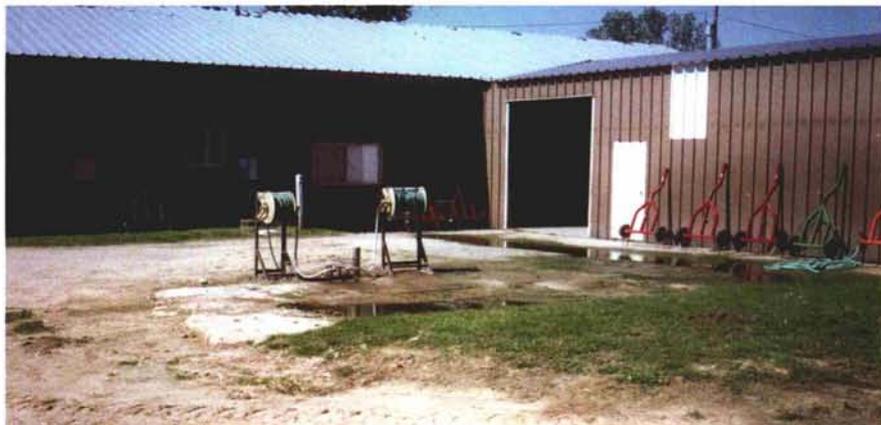
Failing drains and stagnant water plagued Prairie Dunes Country Club's wash pad before the upgrade.

Superintendent Stan George had long felt the club needed a new wash rack system. The old wash pad consisted of two hoses on a 400-square-foot, irregular concrete base. Constructed from concrete left over from past projects, the uneven surface caused the accumulation of rinse water on the pad itself. In addition, the drains were failing, allowing unfiltered rinse water to stagnate above ground and potentially degrade groundwater.

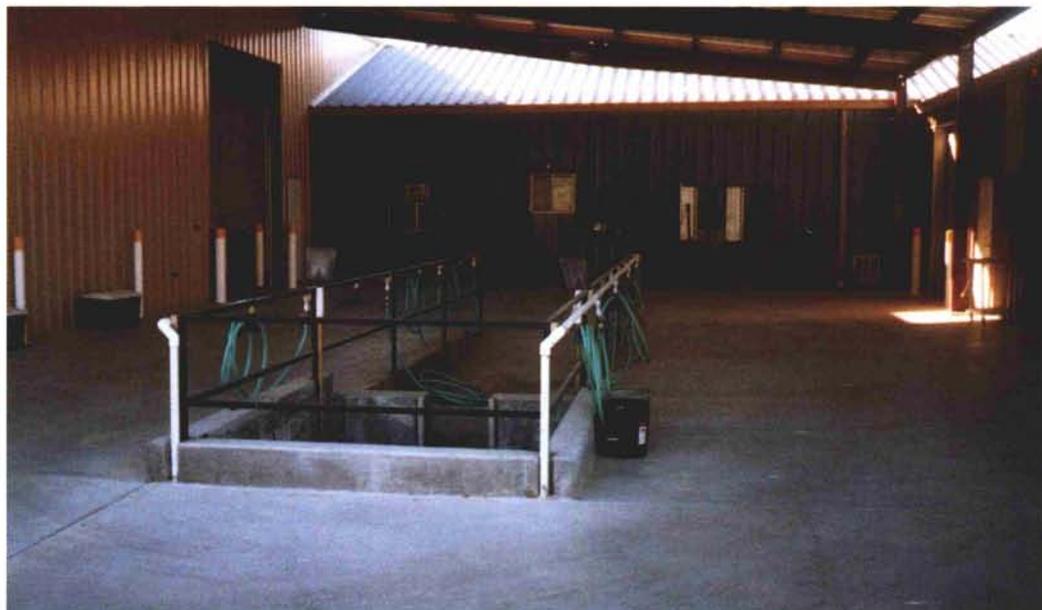
The redesigned and greatly improved wash pad at Prairie Dunes Country Club provides adequate collection and filtering of wash water.

water separator tank, much like a septic tank. The filtered water is discharged into a leach field.

The design of the system is quite simple. The concrete pad is slightly sloped to enhance rinse water and clipping movement into the collection pit from both sides. Rinse water is double screened to collect clippings before passing through a buried oil/
