Forty Years With A Drainage Problem

by JAMES W. DUDLEY, Athens Country Club, Athens, Georgia

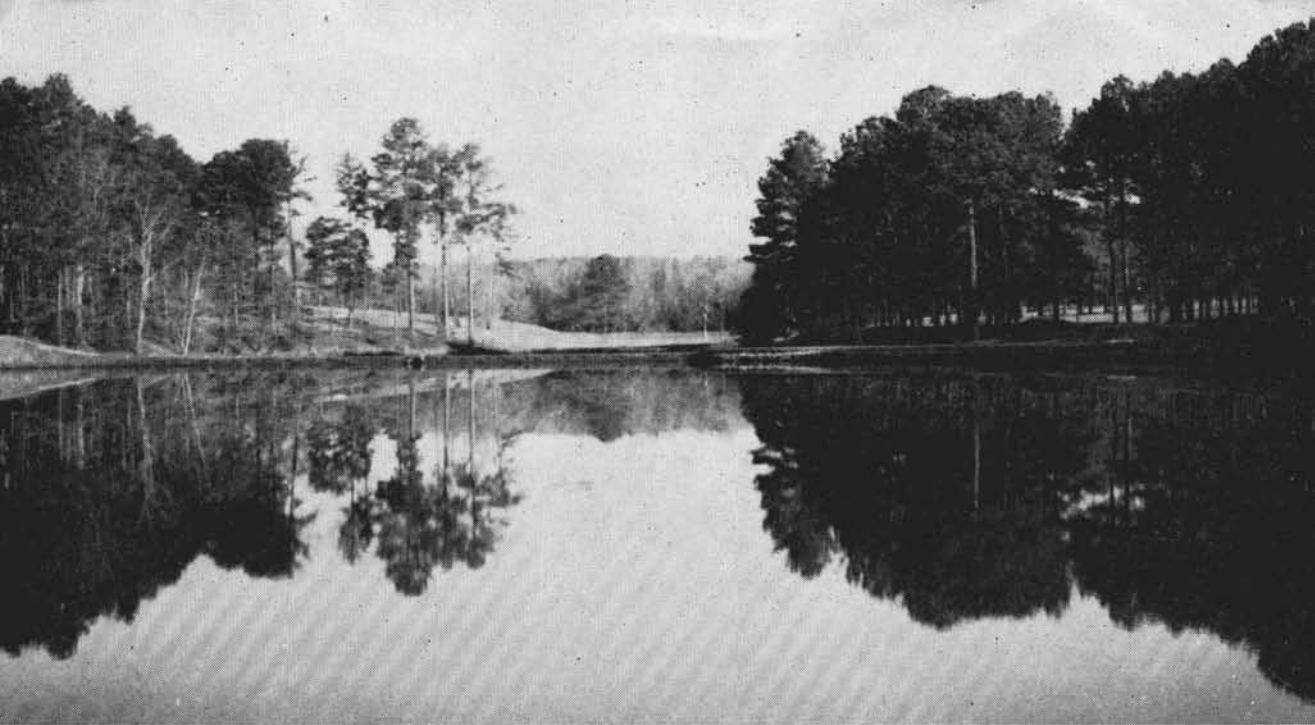
The 11-acre lake used for irrigation and recreation at Athens Country Club. The golf course crosses the lake four times.
