Solving Drainage Problems at El Macero

by **D. W. HENDERSON*** and **DON T. BRADLEY**, Department of Water Science
and Engineering, University of California, Davis, and
JACK JAGUR, Superintendent, El Macero Country Club, El Macero, California

After several greens at El Macero Country Club deteriorated badly in 1966 and large areas of grass died, several possible causes were investigated. Also, some different procedures for drainage were tried and evaluated. Possibly our experiences may be of value to others with problem greens.

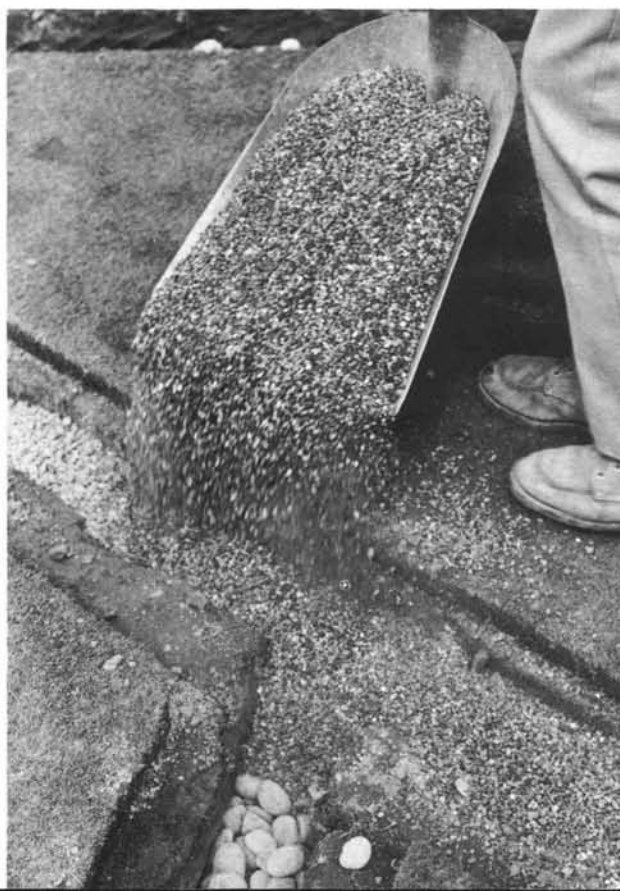
Backfilling the drain lines with graded gravel to be followed with sand. The original sod (with a sand base) will then finish the job.
