How We Cut Irrigation and Electrical Pipe Costs

by **D. GRANT MAINLAND**, Director of Recreation & Parks
and
DENNIS PLATO, Golf Course Maintenance Superintendent

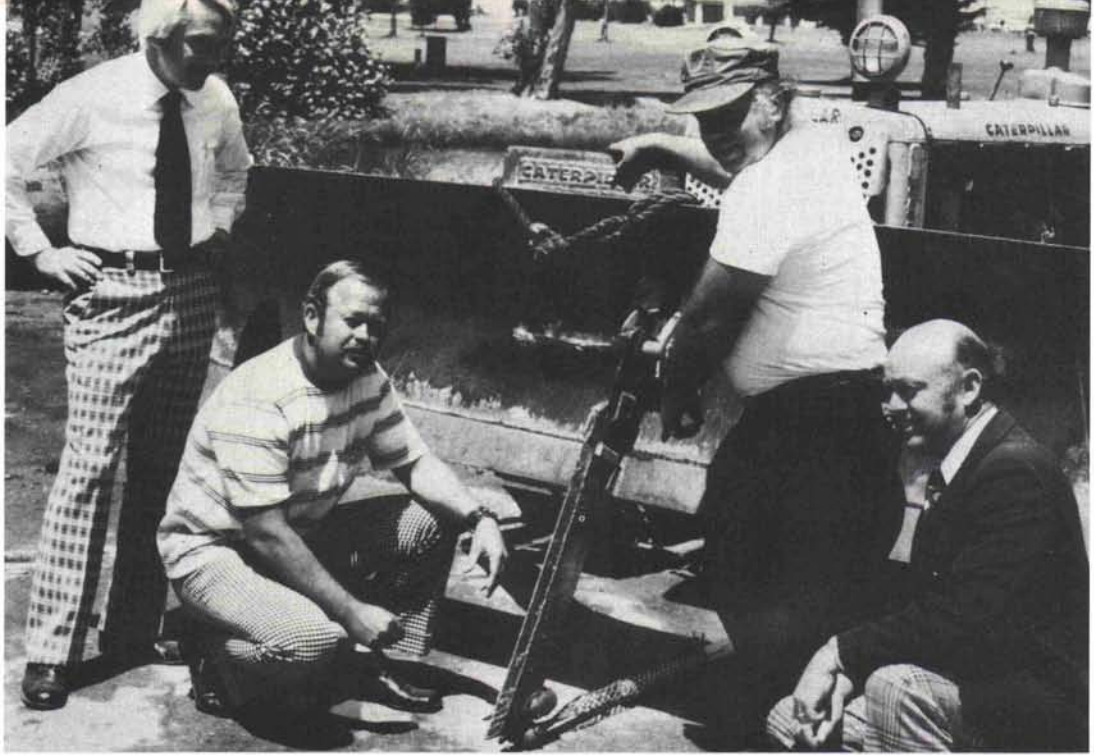
The Team (left to right, R. Harrison, D. Plato, G. Acia and G. Mainland) and the pipe puller at Alameda.

As noted above, both irrigation pipe (PVC) and electrical conduit can be pulled with this equipment. The ground must be fairly solid so that the tractor treads don't sink in too deeply. Eliminated is the need for cutting and removing sod and the use of a trencher, which means backfilling, replacement of sod and the possibility of uneven ground around the cut after the completion of the project.

The crews found that it is well to glue the pipe the day before the operation. Basically, only two men are needed to pull the pipe once the holes for the inspection box every 200-250 feet are dug. With the aid of an auger (which was not available at the Alameda Course), it is estimated that ten hours labor on each fairway could be saved! One man runs the tractor while the other connects and disconnects the plastic pipe.

pull as much as 8,000 feet per day under ideal conditions. Under normal conditions, 4,000 feet can be replaced in a working day. When working around tees and greens and making 90 degree turns, the process slows somewhat primarily due to the need to be centered over the main line.

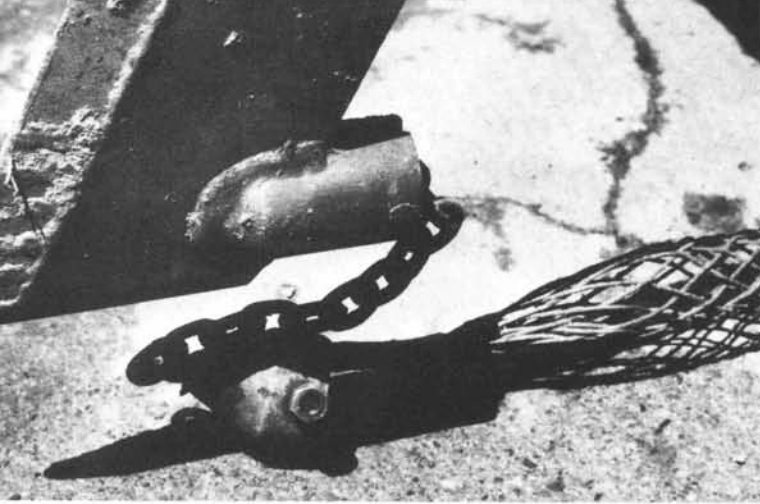
The business end of the puller.

It was finally decided that the basic piece of equipment was to be the D-4 caterpillar tractor. A blade to be used for pulling the pipe and cutting

through the sod and earth was purchased for \$135. A hole was drilled in it for \$16 and a basket assembly (electrical pull basket) for plastic pipe 1 1/4" x 2" was obtained from the City's Bureau of Electricity. With this, the pulling of pipe was ready to start. One bolt connects the whole assembly.

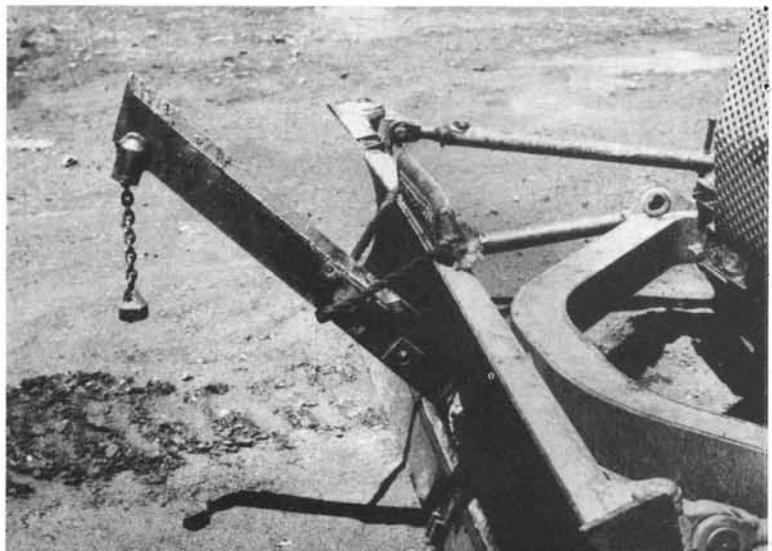
For less than \$200, ingenuity fashioned the pipe puller.
