Some Recent and Unusual Experiences in Golf Course Design

by **ROBERT MUIR GRAVES**

Past President, American Society of Golf Course Architects

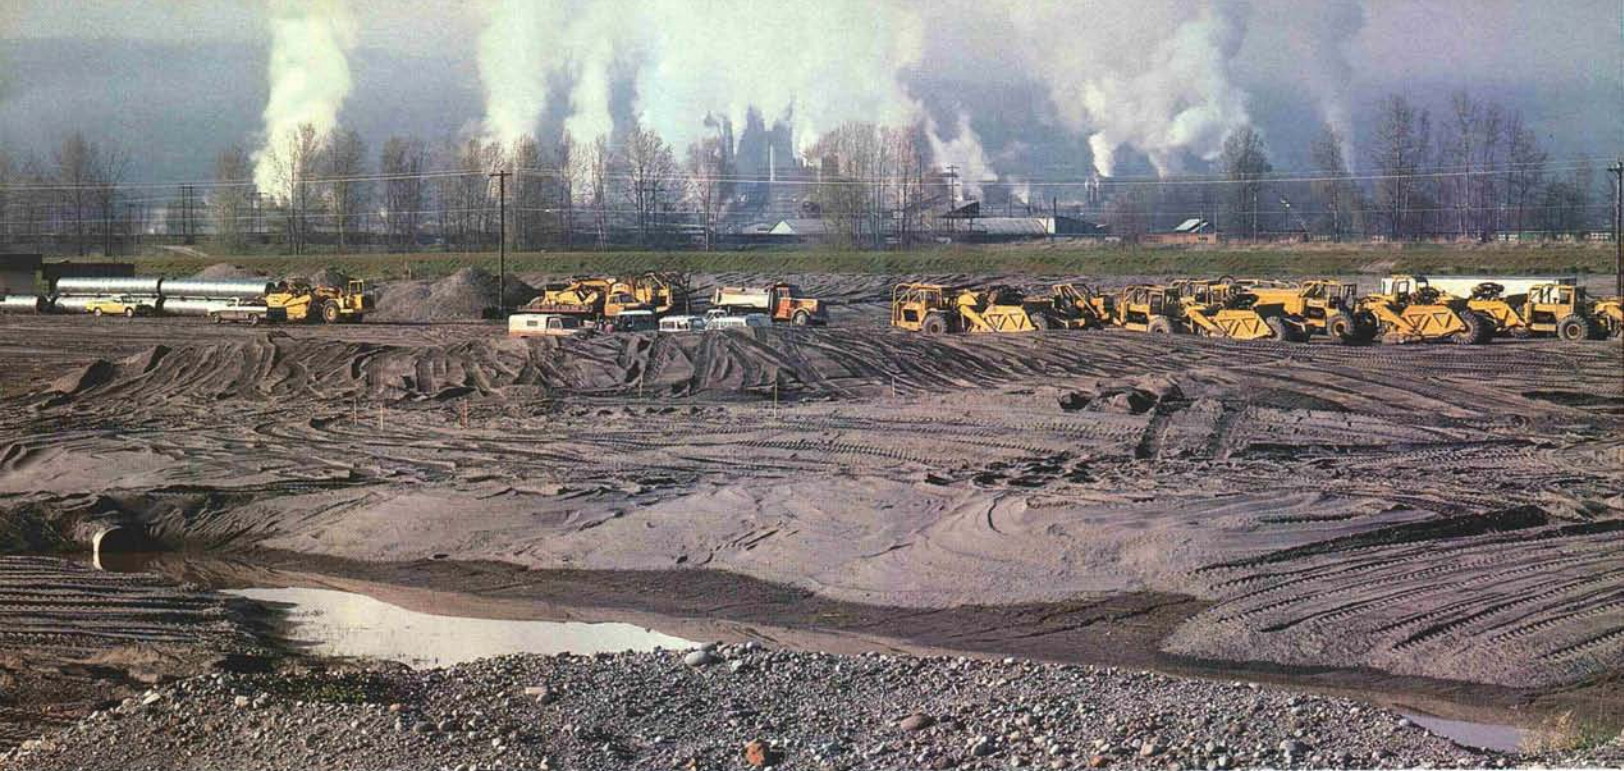
Some of the earth-moving equipment and haul-road culvert used during rough grading for the Kelso course.

When the Corps finished the pumping and the rough grading it agreed to do, our golf course site was covered with thousands of cubic yards of gray sand, in some areas to a depth of 35 feet, or as tall as a four-story building. It was leveled and contoured to my design and specifications, and you may be certain that the potential cost of maintenance was reduced substantially, because we could sculpt the course completely out of this excellent soil. We had our choice of golf course feature shapes, sizes, and gradients.

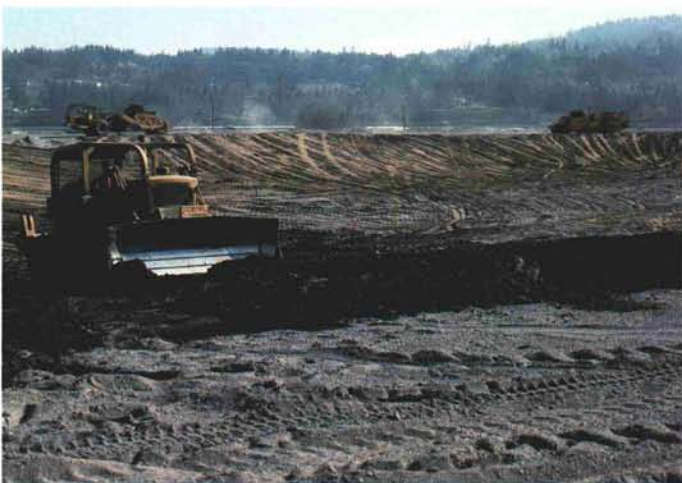
(Above) This is a comparison of the native soil with the grey ash which was the fallout from Mount St. Helens and was dredged from the Cowlitz River. (Right) Green Number 13 built on top of a former garbage dump. Recapping with the same sand fill worked very effectively.

While I frantically tried to determine the quality of the material and how much there would be, the pumping started. It was a great relief to learn from Dr. Roy Gross, agronomist and turf specialist at Washington State University, that the ash was more like sand and was comparable to the material used for green construction. What we were going to have was an entire golf course with a high-quality, unusually deep soil.
