## The Best Turf Tips of 1995

## YOU CAN BANK ON IT!

by DAVID A. OATIS

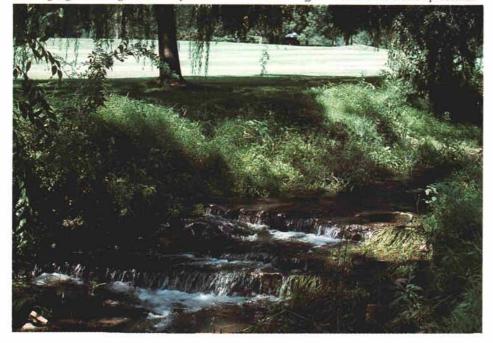
Allowing vegetation to grow naturally is an attractive and cost-effective solution to erosion problems.

Allowing vegetation to grow helps slow water flow, protects banks from scouring, filters out sediment, and lowers water temperatures. Beneficial habitat is also created. The taller vegetation can provide a lovely naturalizing feature that can improve aesthetics, but there is a downside: The longer vegetation can also trap golf balls, and this is why it can be a very controversial program. The program should not be undertaken without a carefully thought-out publicity campaign. It is critical to inform the golfers what to expect, and to provide them with the rationale behind the idea before the vegetation begins to grow. After all, "beauty is in the eye of the beholder," and what may appear as a lovely naturalized stream bank to some will to others undoubtedly look like an unkempt, weedy mess caused by laziness. Slide presentations, newsletter articles, and tasteful signage on the golf course are all good ideas. Be sure to emphasize the positive results and do not be afraid to make concessions in areas where playability is a problem. Allowing for longer vegetation also may alter how a hazard is marked, so be sure to discuss this possibility with a qualified Rules official.
