# ANOTHER COVER-UP

*An inexpensive, effective way to maintain dry topdressing.*

by BOB VAVREK

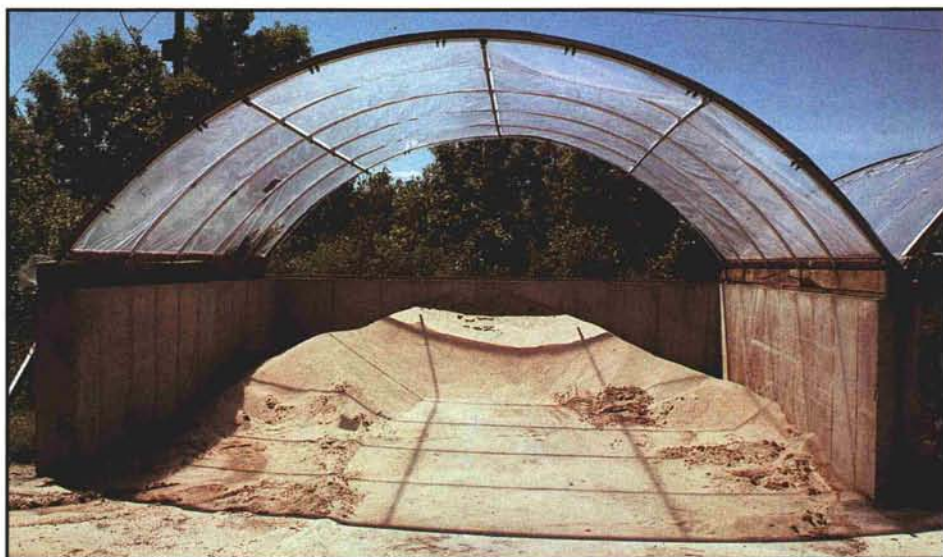
*A plastic-covered roof can readily be installed over existing topdressing bins to provide effective protection from the elements.*

The framework for the cover consists of parallel metal hoops mounted in holes drilled into a railroad tie base. The holes must be drilled at a fixed angle into the ties to ensure a consistent height across the top of the structure. The hoops are placed at four-foot intervals along the ties and stabilized by three metal-pipe crossbars. Lengths of pressure-treated lumber (10' x 1" x 4") are bolted at the base of the hoops along the railroad ties to hold the plastic cover in place. Three-foot lengths of the lumber are used to secure the plastic cover along the arc of the front and back hoop.

The pressure-treated wood is anchored to the metal hoops using 3" carriage bolts through a flat steel bracket. The brackets are made by cutting a length of  $\frac{1}{8}$ " x  $\frac{1}{2}$ " steel stock into 3" sections and drilling a hole at each end to accept the carriage bolt. A 6-mil-thick plastic sheet, treated to resist UV degradation, is then used to cover the hoop framework. The plastic is stretched across the hoops and secured to the boards along the base of the railroad ties by sandwiching the sheet between another length of 1" x 4" lumber. One-inch wood screws are used to fasten the two boards together once the plastic is pulled tightly between the wood. A length of rain gutter can be mounted along the railroad ties, where the plastic meets the top of the bin, to collect and move water away from the base of the topdressing shelter.
