# Light Rate – Results Great!

A simple, fast, and safer way to apply fertilizers, fungicides, and plant growth regulators for the entire golf course.

### by WALT SMITH

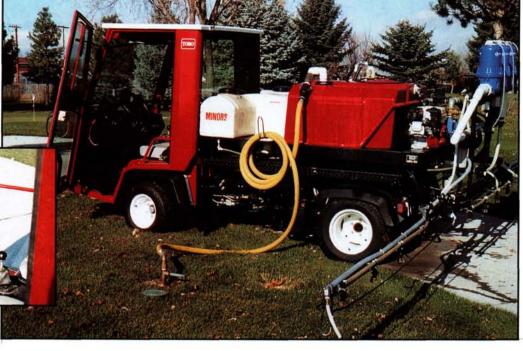
Plumbing the tank for a 1" hose and attaching a 1" quick coupler to the end facilitates refilling on the golf course. With 20' of hose, the operator is able to fill up at any green in about a minute. The quick refilling time makes the 100 Missoula Country Club (Montana) built an innovative spray unit capable of making light, frequent liquid applications. There is no need to tank mix the chemicals, the unit can be refilled on-course, and the sprayer can apply multiple products with one pass.

Finding an injection system that worked flawlessly made the rest of the sprayer construction a matter of procuring the necessary parts and attaching them accurately to the right vehicle. The choice for a vehicle was a twowheel-drive Toro Workman with an enclosed cab, flat bed, and a 21 hp diesel engine. This vehicle is very maneuverable and easy to operate. The governor is easy to adjust and, surprisingly, maintains speeds very consistently.

A Hypo centrifugal pump with a gear reduction was chosen, model #9006P-0. The pump is driven by a Honda 5.5 hp electric-start motor.

Pulley sizes for the pump and motor were 14" and 3", respectively, using twin-belt pulleys. An electric start allows the operator to turn the pump off and on from the cab. The centrifugal pump is capable of 90 gpm and only about 70 psi. This eliminates the need for a pressure relief-valve and gives us the ability to control pressure with the Honda's engine speed rather than with a pressure-regulating butterfly valve. Very little drop in pressure versus static pressure is desired when spraying. The minimal pressure drop is due to the high volume of water recirculated by the centrifugal pump through 1" plumbing, versus the relatively low demand (6 gpm) of the spraying system. Controls for the engine are located in the cab for easy start, shutoff, and engine speed control, and once the engine speed is set, it does not vary, giving us consistent spraying pressures. After the Honda and Toro governors are set, the operator need only keep vigilance over the area being sprayed.

Spraying controls consist of a bank of three electric solenoid valves, giving us the option of using one, two, or three boom sections. Booms are hydraulically lifted and lowered and are independent of each other. We use a foam marking system with small tube outlets that leave a fine line of foam that disappears in a matter of minutes, and with the small outlets we do not have to worry about running out of foam before we finish a nine-hole application. Electric gate valves are used to control which side the foam is emitted from. The only other control is a pressure gauge so the operator can monitor spraying pressures. With a total of six switches and two throttle controls, operation of the sprayer is very easy after the initial setting of the throttle governors.
