# Gumption in Grand Junction

Renovation and new irrigation installation was a long time planning, but worth the wait!

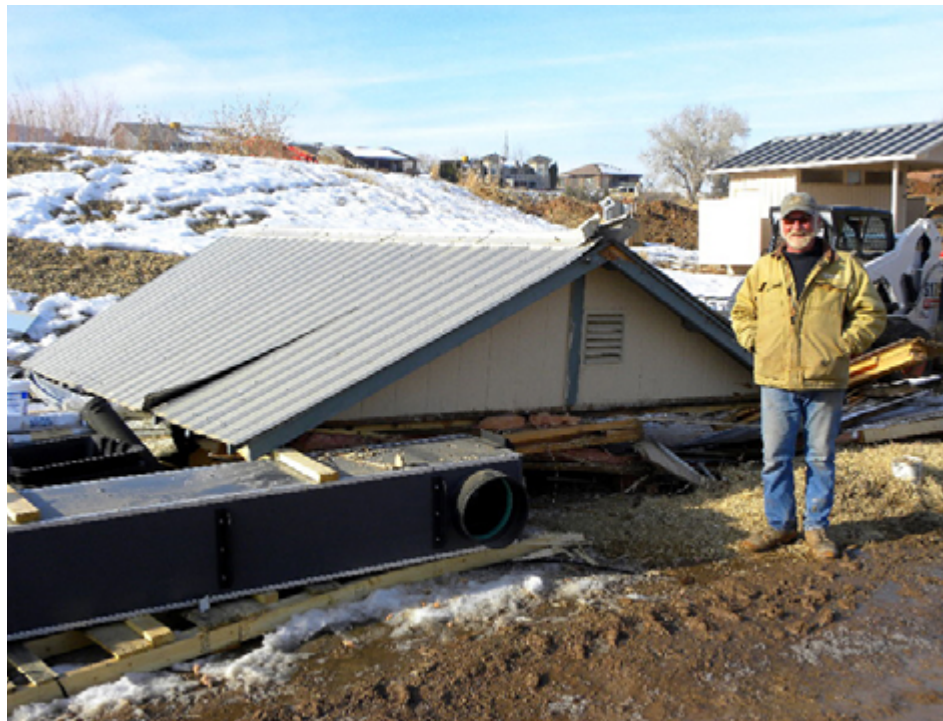
*Assistant Superintendent Dave Carter enjoying a happy new year in 2010 with the demolition of the old pump station!*

*stretched head spacing* or heads placed too far apart from each other in most areas and did not provide adequate irrigation coverage. The two previous pump stations, each with three 20 HP pumps, ran at approximately a 35-percent energy efficiency level. There were as many as four irrigation heads on each of the old block irrigating zones, making precision irrigation impossible. The 700 brass impact sprinkler heads could not be repaired, as parts were no longer available. Numerous labor hours each day were spent repairing breaks in the old polyvinyl chloride (PVC) plastic pipe mainlines, and four to five staff members each day spent hours moving around hoses and portable roller-base sprinklers. Finally, the old system required a separate budget line item for irrigation repair of \$12,000 a year for maintenance, just to be able to irrigate the golf course.

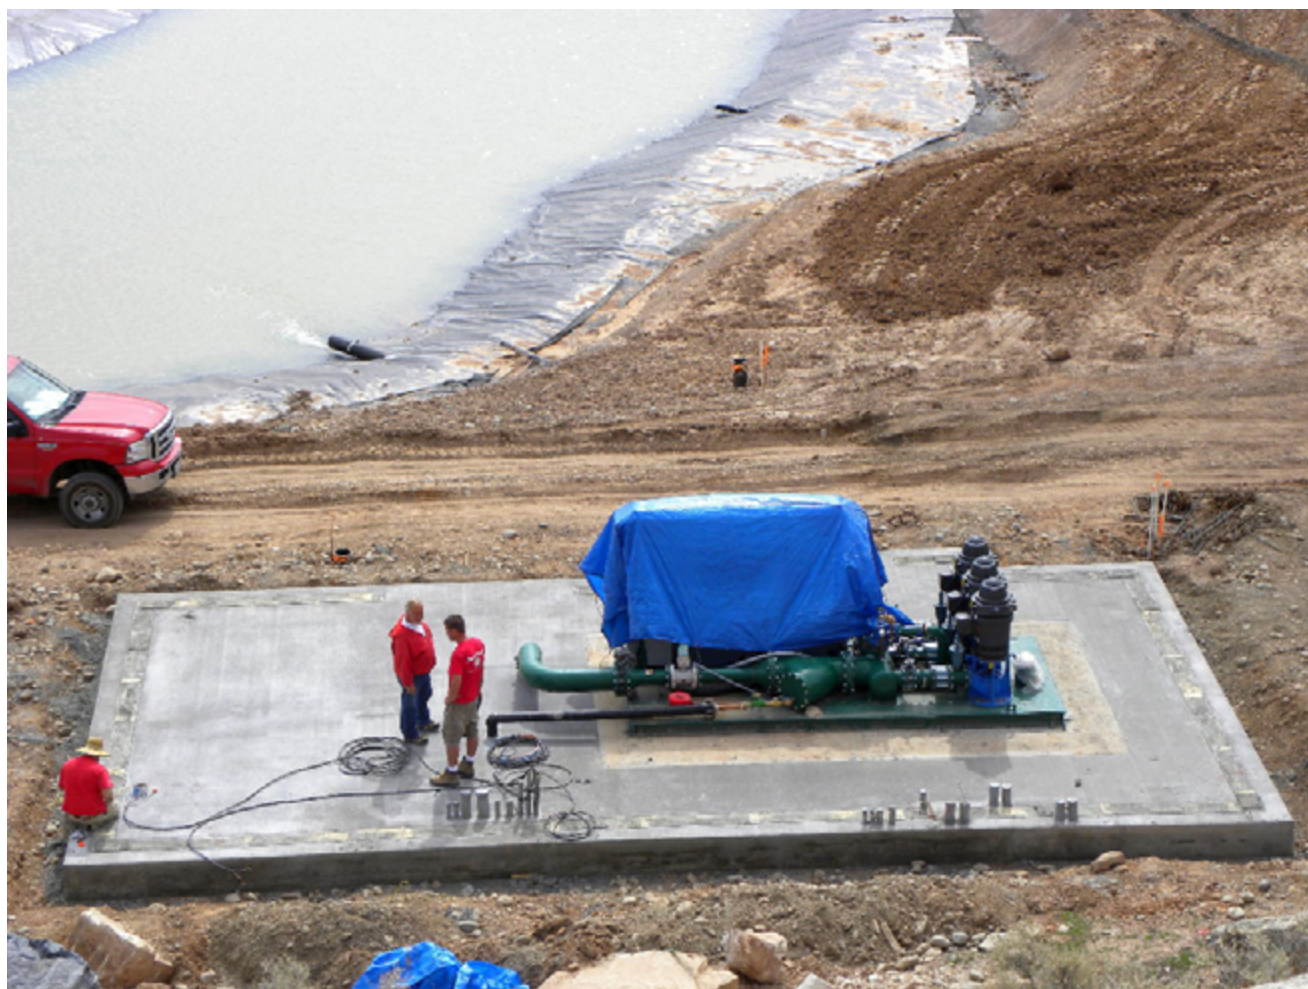
The new Rainbird pump station and pad for the new building in March of 2010.

A new Rainbird pump station is now the heart of the irrigation system. It has three 75 HP variable frequency drive (VFD) pumps that are much more efficient to move water throughout the golf course. It sends water to 1,500 new Rainbird Eagle heads, each with valve in head and individual head control. The irrigation central computer system was the only component not replaced, but the software was upgraded from Rainbird's Nimbus 2 to the Sirius System.

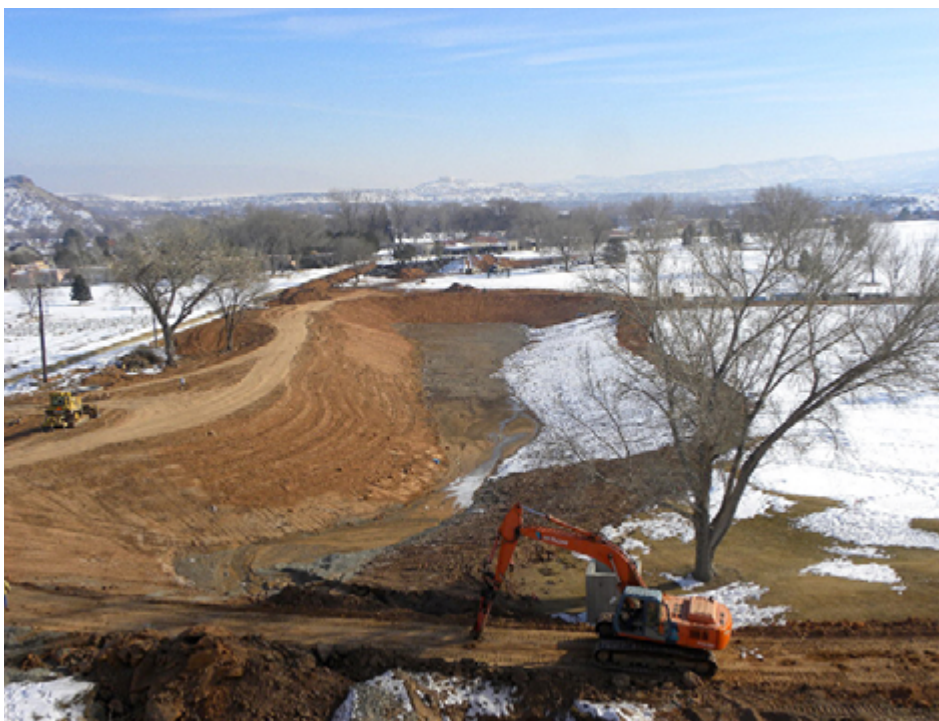
*Beginning of the new irrigation holding pond and new lake feature on Hole No. 10 in January of 2010.*

All the irrigation pipe is new, utilizing high-density polyethylene (HDPE). There is an 18-inch-diameter pipe coming out of the pump house that has 12-inch mainlines throughout the golf course, and the smallest lateral line is two inches (for additional information, see the article [HDPE vs. PVC, What's the Difference?](#)). With the addition of three new irrigation ponds, the storage

capacity is now approximately 12 million gallons. Being able to have water available in the colder seasons of early spring and late fall is proving valuable in maintaining turf health. They are now only using about 600,000 gallons of water on a typical summer day and are able to efficiently water the course in about four hours. That's a *daily savings* of about 400,000 gallons of water and eight hours of running the electric-power pump station.

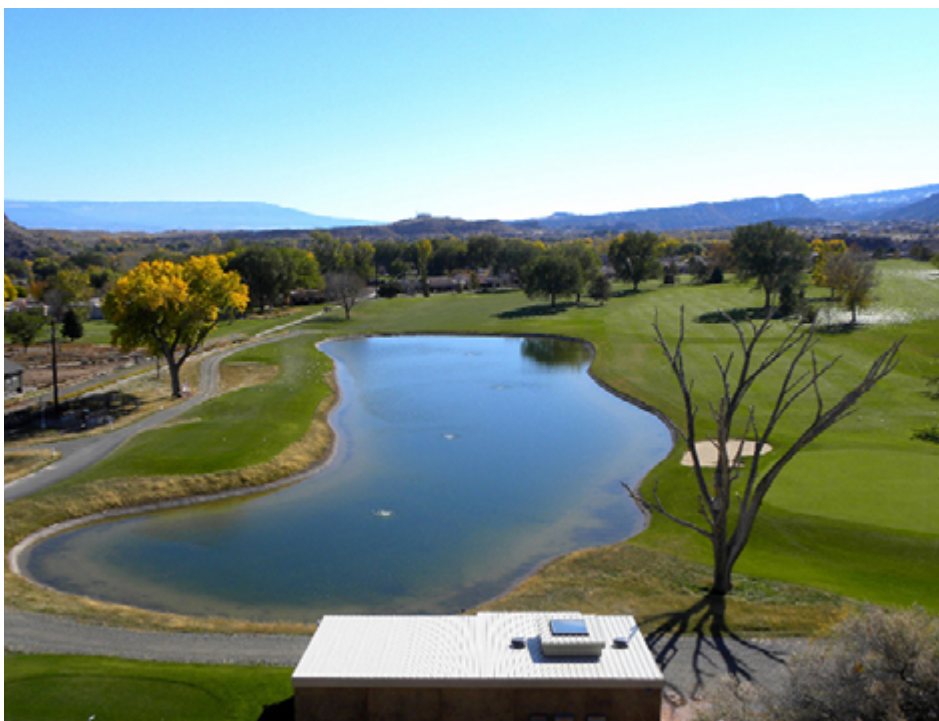
*Holes No. 10 and 11 of Tiara Rado Golf Course and new pump station building, November of 2011.*
